This Service Information bulletin supersedes S.I. B84 01 03 **dated August 2005**.

### CPT9000 Telephone

E46 (3 Series) from 9/03 to 3/05 production with Premium Package (ZPP) or BMW Assist (SA 639)

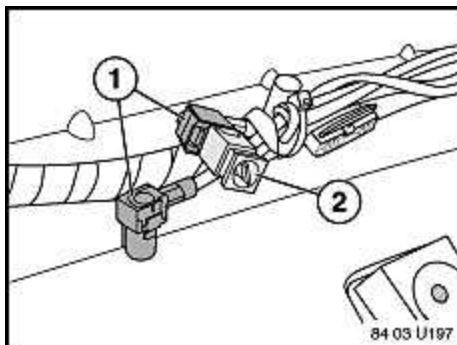
3. Locate the vehicle harness that runs down the left side of the trunk.
4. Remove the protective cap (2) from one of the antenna cables.
5. Connect both antenna cables (1) together and resecure the cables to the harness. If this connection is not made, the mobile phone calls will fail to make a connection.

2. Remove the left rear trunk trim panel (E60). **For the E63/64 this connection is located behind the driver's side rear seat back panel.**

6. Reinstall the left rear trunk trim panel.

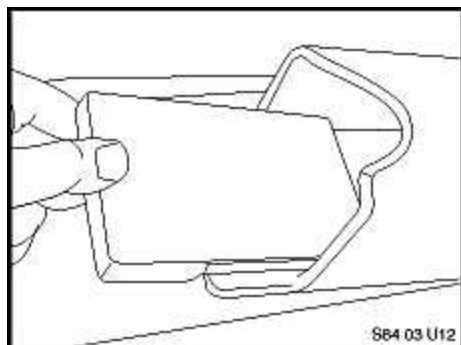
- The eject box no longer has a coil cord and accepts the handset directly with the help of a "thick" spacer (P/N 84 21 6 922 575) which is required for the standard battery. If an extended battery is used with the handset a "thin" spacer (P/N 84 21 6 922 574) will need to be installed in the cradle. The spacer slides into the bottom of the cradle. Without this spacer the handset will not properly engage the connector inside the cradle. Early production vehicles were shipped without the spacers installed. BMW

automatically sent the "thick" spacer, along with an instruction card, for dealer installation.
