This Service Information bulletin reactivates S.I. B12 01 04 **dated April 2004.**

**NEW** E60 with N62; DME Reprogramming

**NEW** E60 with N62 engine produced up to 09/01/2003 up to 03/31/2004

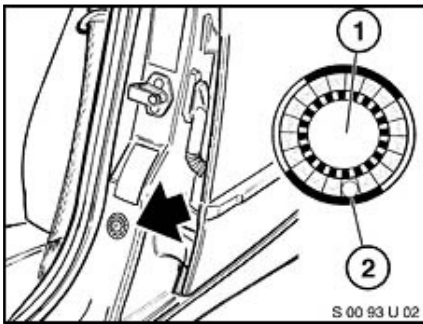
This Service Action has been assigned code number **397**. After the vehicle has been checked, and corrected if necessary, obtain a label (SD92-245) and:

- a. emboss your BMW dealer warranty number in the middle of the label (1);
- b. punch out code number **397** printed on the label and,
- c. affix the label to the **B** pillar as shown.

If the vehicle already has a label from a previous Service Action/Recall Campaign, affix the new label next to the old one. Do not affix one label on top of another one because a number from an underlying label could appear in the punched-out hole of the new label.
