Non-Return Valve Parts Found In Engine Oil Filter During Engine Oil Service

E60 (5 Series) 545i, E63 and E64 (6 Series) 645Ci and 645CiC, E65 and E66 (7 Series) 745i and 745Li, E53 (X5) 4.4i and 4.8is equipped with N62 engine

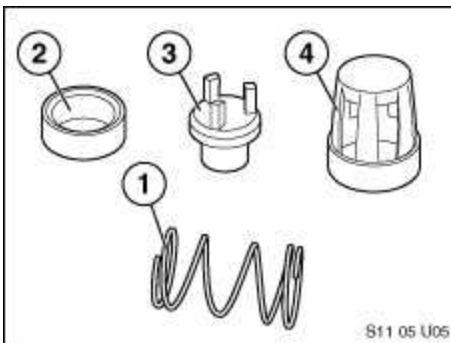
Engine Oil Pump Non-Return Valve Parts:

While performing an oil service, removal of the oil filter may reveal one or more of the following parts have dislodged from the engine oil pump. These parts make up the internal non-return valve inside the engine oil pump. The customer does not complain of loss of oil pressure while driving or does the vehicle exhibit any drivability complaints.

1. Metal Spring
2. Metal Spacer
3. Plastic Plunger
4. Plastic Cap

Note: These parts are not related to the oil pressure regulator located within the engine oil pump. The engine will not lose oil pressure while being operated.

Submit a Puma Case to the Drivetrain Group indicating "N62 Oil Pump Parts in Filter" in the subject field. Do not release the vehicle until a response is received.
