Mew designates changes to this revision SUBJECT

Recall Campaign 10V- 446: Inspect Brake Booster Vacuum Supply Line MODEL

E60 (5 Series) with N62 or N62TU engines produced from August 8th, 2003 to November 30th, 2009

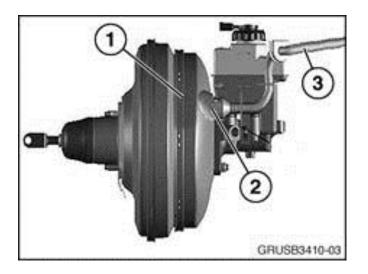
1. Remove the brake booster vacuum supply line (3) together with the non-return valve (2) from the brake booster (1).

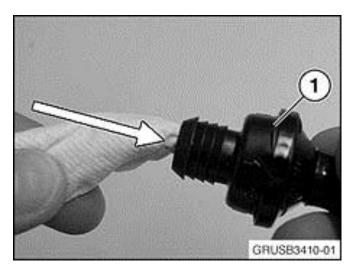
2. Check the brake booster vacuum supply line at the nonreturn valve upstream from the brake booster for contamination of oil. Insert a tightly rolled up corner of a non-reusable lint free white shop towel (see arrow) into the non-return valve (2). If the towel does not indicate any engine oil residue, proceed to step 4.

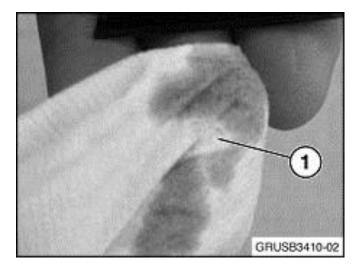
3. If the line exhibits contamination with engine oil, proceed to step 5.

- 4. Replace the following components only if oil contamination is **NOT** found. Refer to the applicable parts list for each model.
 - Vacuum supply line and clamp. Refer to Repair Instruction REP 11 66 000 Removing and installing vacuum pump (vacuum pipe and clamp installation).
- 5. Replace the following components only if oil contamination is found. Refer to the applicable parts list for each model.
 - Brake master cylinder and o-ring. Refer to Repair Instruction REP 34 31 505 Removing and installing or replacing brake master cylinder.
 - Brake servo unit and seal. Refer to Repair Instruction REP 34 33 505 Removing and installing or replacing brake booster.
 - Vacuum supply line and clamp. Refer to Repair Instruction REP 11 66 000 Removing and installing vacuum pump (vacuum pipe and clamp installation).
