This Service Information bulletin supersedes SI B54 02 08 **dated January 2008**.

Water Leak from Sunroof

E60 (5 Series)

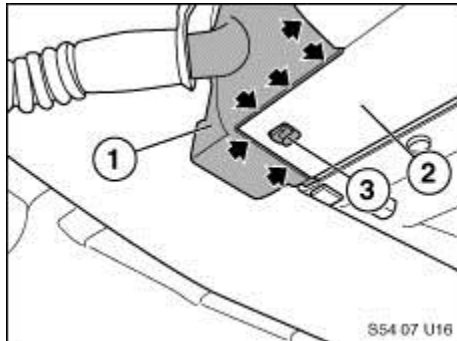
1. Remove the headliner per repair instruction RA 51 44 011 and water test the sunroof to reproduce the customer complaint.
 - a. While water testing, inspect the rear corner drain pockets of the cassette for any signs of water seeping through between the cassette frame and these drain pockets.

b. If any water seepage is observed, apply sealant to the seam where the drain pocket (1) meets the cassette (2). The retaining tab (3) must also be sealed. Wurth Euroseal Gel or a comparable silicone sealant may be used for this procedure.

c. Seal the opposite side of the cassette in a similar fashion as a preventative measure.
