This Service Information bulletin supersedes S.I. B51 02 05 **dated December 2006.**

Squeaking Noise From Door Frame Area While Driving

E60, E61 (5 Series)

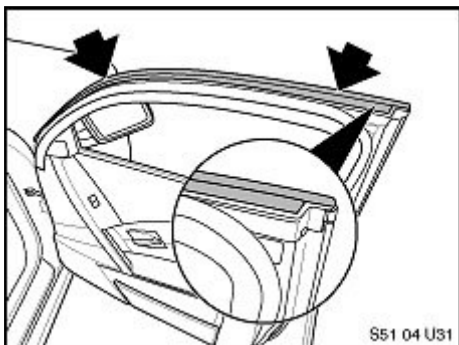
Movement between the flocking material (felt-like material indicated by the arrows) on the upper door seal and the surrounding roof panel may produce squeaking or creaking noises. These noises may be amplified by contamination or cleaner residue on the door opening.

In case of a customer complaint, refer to the procedure outlined below to replace the seals with improved parts and/or apply the specified transparent Teflon tape.

The flocking material was changed in 01/2005 to an improved material with exceptional rigidity, strength, and low moisture absorption.
