This Service Information bulletin supersedes SI B24 08 06 **dated March 2010**.

### ZF 6HP Transmissions - Mechatronic Sealing Sleeve Seepage

**NEW** E53, E60, E61, E63, E64, E65, E66, E85, E90, E91, E92, and E93 vehicles with ZF 6-speed 6HP19/21 or 6HP26/28 transmissions produced up to 04/08

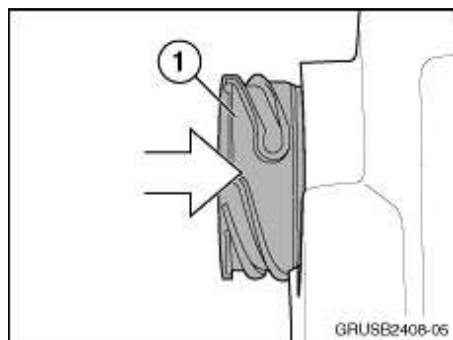
Transmission fluid seepage is visible in the area of the transmission oil pan. In most cases, only an oil "wetness" spot is spotted in the back of the transmission oil pan (the transmission fluid does not drop on the ground).

The Mechatronic sealing sleeve's O-ring tightness

**NEW** The "oil wetness" in the area of the sealing sleeve is not an indication of substantial leak, and does not justify this repair.

**NEW** 1. Only if a visible leakage trace indicates a substantial loss of transmission fluid (e.g., transmission fluid accumulation on the underbody panel), replace the Mechatronic sealing sleeve.

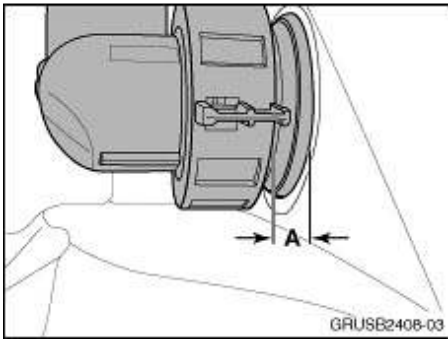
3. After installation, the correct distance between the transmission harness connector and the housing surface (B) should not exceed 3 mm.

When installing the transmission harness connector, do not use excessive force - locking of the connector should not require an increased effort. This would be an indication of an incorrectly installed sealing sleeve!!!

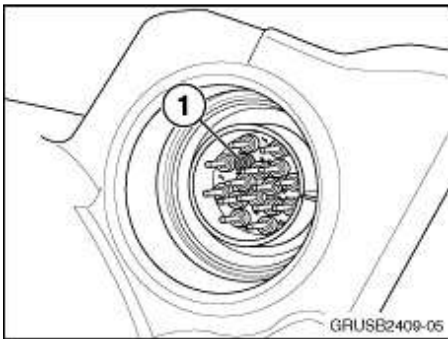
**NEW** 4. If the distance between the connector and the transmission housing (A) measures approximately 7 to 8 mm, the sealing sleeve was installed incorrectly. In such a case, an intermittent connection problem between Mechatronic and the vehicle harness connector will occur, resulting in various EGS communication faults (e.g., FC 5079 "Serial wire message missing"; FC 507A "Serial line signal plausibility"; "Gearbox Emergency Program" lamp illumination; and the transmission entering a failsafe mode).

5. In some cases, the incorrectly installed sealing sleeve may permanently damage pins in the Mechatronic connector (X8500). In such a case, the Mechatronic module has to be replaced (**pin repair is not possible**). The illustration shows an example of a broken and missing pin #4 in the X8500, caused by improper sleeve installation; this resulted in the customer's complaint about the inoperative Sport Mode of the transmission.
