This Service Information bulletin supersedes SI B61 13 06 **dated February 2009.**

Various Electrical Problems Caused by Water Ingress

E60 (5 Series)

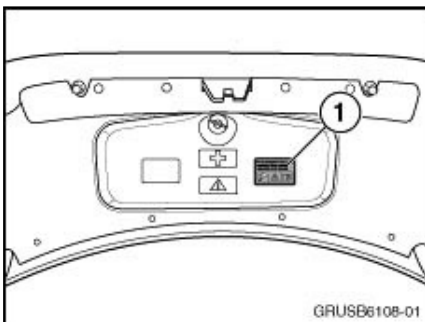
- a. Relocate the RDC module to the left-hand side of the trunk per Repair Instruction RA 36 11...
- b. **NEW** Relocate both the SDARS and PDC modules, if so equipped, per the attached repair procedure **SI B61 13 06 Procedure.pdf**.
- c. In the bottom of the trunk are 4 stamped openings in the sheet metal which are filled with seam sealer. Drill a 1-2mm one hole through the center of each of the forward 2 stamped openings only.

NOTE: The drilled holes should only penetrate the seam sealer and not the steel floor pan.

d. Install a warning label (PN 71 24 6 777 721) on the right side of the tool kit cover (1). The customer should be notified of the label and the fact that liquids should not be present on or under the trunk insulation, due to the sensitive nature of the electronic control units located in the spare tire well.
