# IMPORTCar

## Tech Tip: BMW's Power Reduction and Vanos Faults Are Stored In DME

January 31, 2012

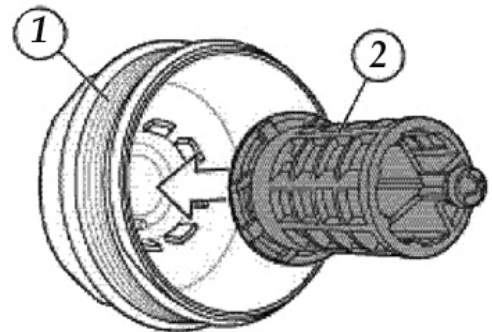
*Fig. 1*

2. The oil filter cap insert may have been inadvertently removed during the vehicle's last oil service. If this insert is not installed, it

will result in non-filtered engine oil being supplied to the engine, thus possibly clogging or damaging the VANOS solenoids.

If the oil filter cap insert is found to be missing, the entire oil filter housing cap must be replaced (refer to the EPC).

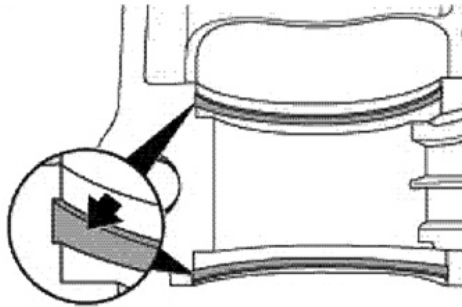
Fig. 2

**Figs. 2, 3 and 4** are illustrations of worn *Fig. 3* camshaft bearing ledges and the acceptable wear of the camshaft bearing ledge.

If excessive wear to the camshaft bearing ledge is found, it is only necessary to replace the camshaft hook ring seals and the affected camshaft bearing ledge. N51, N52 and N52K intake camshaft bearing ledges and hook ring seals cannot be replaced separately. Cylinder head replacement requires a TeileClearing PuMA case.

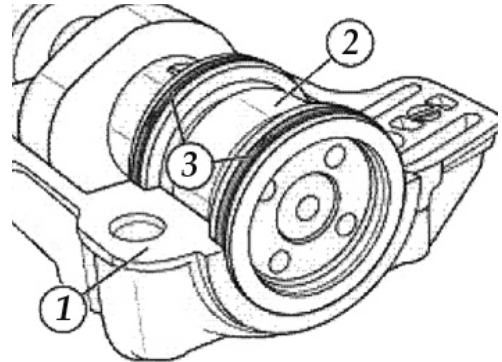
Note the deep grooves worn into the camshaft bearing ledge by the camshaft hook ring seals in **Fig. 3**. The camshaft bearing ledge is worn.

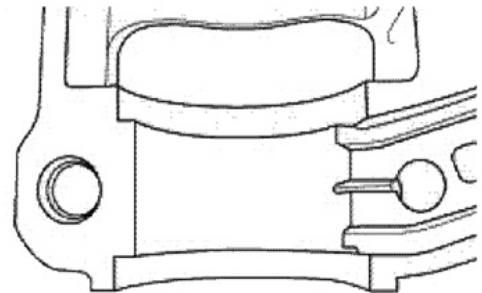
Fig. 4

**Fig. 4** shows acceptable camshaft bearing ledge — minor gray wear marks from the rotation of the camshaft are normal. If deep grooves are not apparent, the camshaft bearing ledge is acceptable and should not be replaced.
