E65, E66 with 6HP26 - Diagnosis for EGS FC 4F81

E65, E66 with N62TU and ZF 6HP26, produced from 03/05 up to 10/06

E65, E66 with N73 and ZF 6HP26, produced from 03/05 up to 10/06

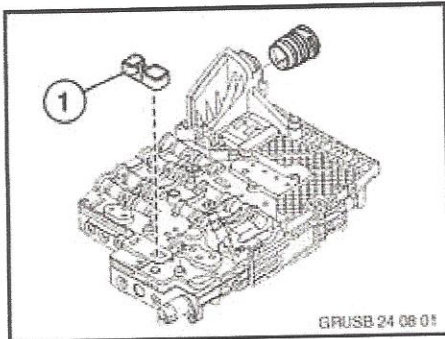
- Low transmission fluid level; or
- **NEW** Internal transmission pressure leak caused by a defective adapter seal (rectangular) between the transmission housing and the Mechatronic.

- 4. In case the Mechatronic adapter seal (rectangular) (1) is found to be defective (cracks, seal damage, etc.), replace it with the new part (P/N 24 34 7 588 727).
- 5. Reinstall the Mechatronic and an oil pan, using a new oil pan gasket (P/N 24 11 7 520 712) and the new Mechatronic sealing sleeve (round), P/N 24 34 7 519 357.
- 6. Fill and adjust the transmission fluid, using the previously-saved Shell M-1375.4 (P/N 83 22 0 142 516). For the filling procedure, refer to TIS RA 00 11 500.

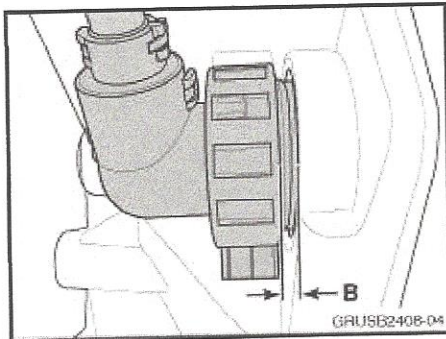
In case the sealing sleeve is not inserted correctly, an intermittent connection problem between the Mechatronic and the vehicle harness connector will occur, resulting in various EGS communication faults (e.g., FC 5079 "Serial wire message missing"; FC 507A "Serial line signal plausibility"); "Gearbox Emergency Program" light illumination; and the transmission entering failsafe mode.

After installation, the correct distance between the transmission harness connector and the housing surface (B) should not exceed 3 mm.
