This Service Information bulletin supersedes S.I. B84 01 03 **dated August 2005.**

SUBJECT

CPT9000 Telephone

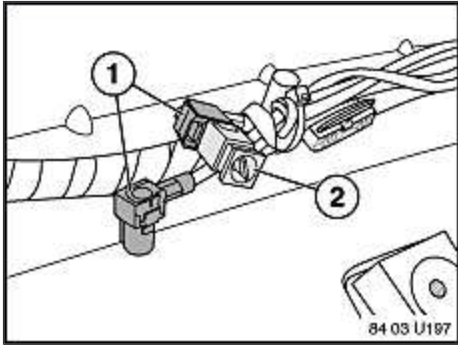
4. Remove the protective cap (2) from one of the antenna cables.
5. Connect both antenna cables (1) together and resecure the cables to the harness. If this connection is not made, the mobile phone calls will fail to make a connection.
6. Reinstall the left rear trunk trim panel.
