SIB 11 01 22

2022-08-22

RECALL 22V-119: POSITIVE CRANKCASE VENTILATION (PCV) BLOW-BY HEATER

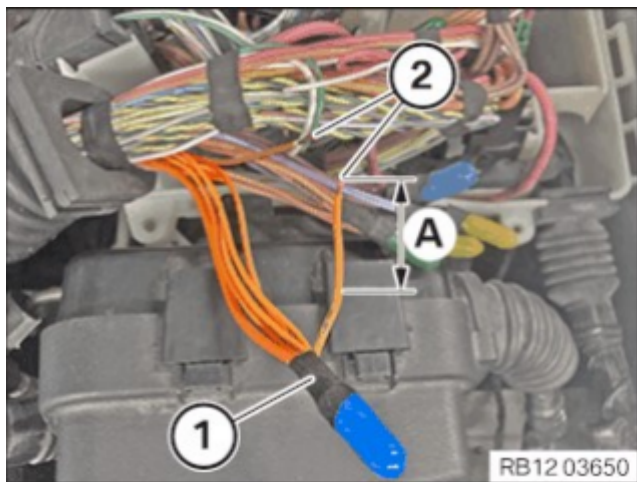
Repair Instruction 00 72 067 “Retrofitting component protection and checking function of angle fitting” indicates the splice cap is blue, this is not the actual color of the splice cap.

The picture has been edited to highlight the splice cap with blue coloring (1).
