**Recall Campaign 06V-277: Inspect Rear Shock Absorbers**

E60, E61 (5 Series)

E63, E64 (6 Series)

E65, E66 (7 Series)

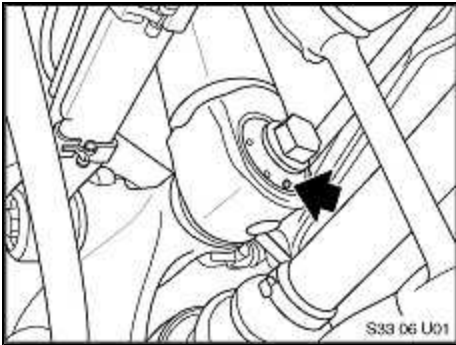
The defect involves the rear shock absorbers. Specifically, the lower rubber bushing may not have been manufactured to specification. Depending on vehicle operation and temperature conditions, this could lead to a loosening of the bushing within the shock absorber housing. If this condition was not corrected, then over time, the bushing could continue to loosen. Eventually, the bushing could separate from its housing.

With the vehicle properly supported on a lift, inspect the rear shock absorbers for a blue paint dot as shown in the illustration.

If the blue dot is present, no further action is necessary.

**If there is no blue paint dot, the rear shock absorbers must be replaced.**

The repair consists of inspecting the rear shock absorbers and replacing both rear shock absorbers as necessary.

Refer to Repair Instructions as follows.

E60, E63, E64, E65, E65: RA 33 52 131 "Replacing the rear left or right spring strut shock absorber"

E61: RA "Removing and installing / replacing rear left or right shock absorber"

E65, E66 with rear air suspension: RA 37 12 070 "Remove and refit/replace the rear left or right air spring strut"
