This Service Information bulletin supersedes S.I. B51 02 05 **dated December 2006.**

Squeaking Noise From Door Frame Area While Driving

E60, E61 (5 Series)

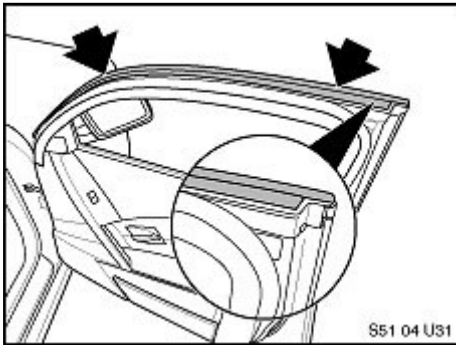
Movement between the flocking material (felt-like material indicated by the arrows) on the upper door seal and the surrounding roof panel may produce squeaking or creaking noises. These noises may be amplified by contamination or cleaner residue on the door opening.

In case of a customer complaint, refer to the procedure outlined below to replace the seals with improved parts and/or apply the specified transparent Teflon tape.
