This Service Information bulletin supersedes S.I. B36 02 05 **dated July 2005**.

Noise and/or Vibration Caused by Irregular Tire Wear

E60 (5 Series) equipped with Dunlop SP Sport 01 DSST Run Flat Tires

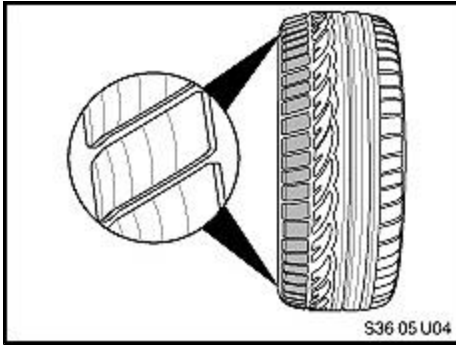
Noise and/or vibration caused by irregular tire wear on Dunlop SP Sport 01 DSST Run Flat tires may be objectionable to some customers. Irregular tire wear may also be noted during a service visit.

Noise and vibration may be caused by the irregular tire wear referenced in this Service Information. The wear

only occurs at the tire's inner shoulder as indicated by the shaded area in the illustration. The tires will have a feathered or scalloped edge on the inner tread blocks. If one or more tires are found with this condition, and the tires have less than 20,000 miles, all four (4) tires should be replaced with similar Dunlop tires, or when not available, with other BMW approved tires.

If this situation is detected based upon a customer complaint and/or during a service visit; and only if the tires have less than 20,000 miles, replace all four (4) tires.
