Retrofitting a Telematics Control Unit (TCU) with Bluetooth® Technology

E60 (5 Series) from 7/03 production to 8/04 production
E63, E64 (6 Series) from 11/03 production to 8/04 production

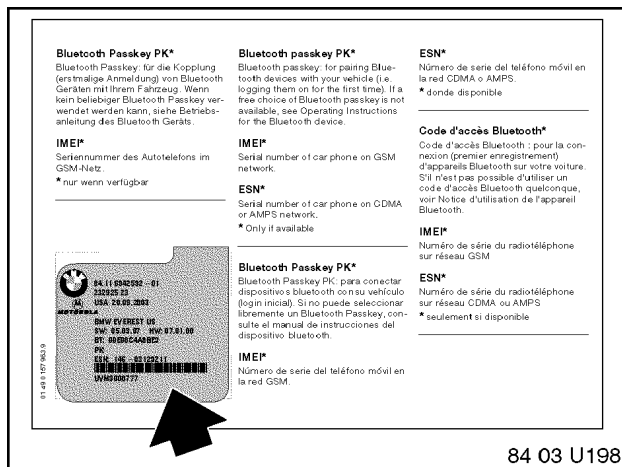
4. The second ESN label of the TCU should be affixed over the existing label in the Owner's Manual insert (P/N 01 49 0 157 963).
