This Service Information bulletin supersedes SI B13 07 09 **dated June 2009**.

### N54 - Diagnosis for "Long Crank" Complaint

E90, E92 with N54 produced from 06/06

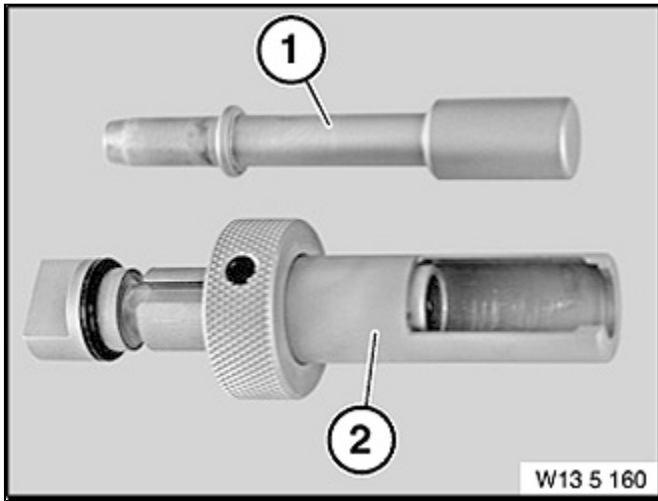
4. Access the quick-disconnect coupling in the fuel feed line. On E82, E88, E89, E90, E92 and E93 vehicles, it is located underneath the car, at the bottom of the driver's side wheel housing. On E60, E61 and E71 vehicles, the coupling is located in the engine compartment, on the driver's side next to the B+ terminal.

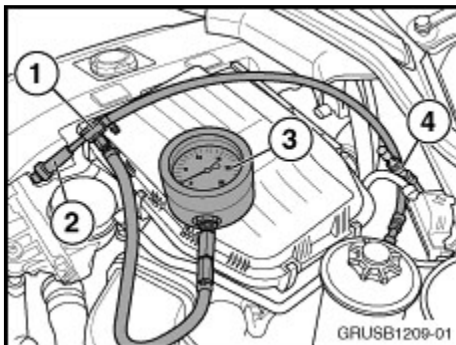
5. Disconnect the fuel supply line and install special fuel line plug tool 135 161 (P/N 83 30 0 496 565), item 1, into the fuel hose from the high-pressure side of the system (item 4 on the next illustration).

6. Install three-way adapter tool 135 270 (P/N 83 30 0 491 310), item 1, into the supply line from the fuel tank side.

7. Connect the properly calibrated mechanical pressure gauge, item 3 (e.g., P/N 83 30 0 491 260 - a pressure gauge from K-L-Jetronic special tool kit P/N 83 30 0 491 259) into three-way adapter tool 135 270 (item 1).

8. Plug the open end of the three-way adapter tool using special tool 135 162 (P/N 83 30 0 496 565) – item 2 on both illustrations.

9. In this configuration, the low and high-pressure fuel systems are separated and sealed. The residual pressure measurement will be performed only on the low-pressure side.

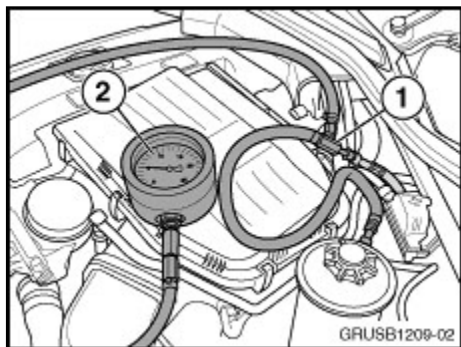
15. Prior to execution of the Low-pressure test module, connect three-way adapter tool 135 270 # 1 (with a calibrated manual fuel pressure gauge # 2 installed - e.g., P/N 83 30 0 491 260 pressure gauge, from the K-L-Jetronic special tool kit P/N 83 30 0 491 259) into the low-pressure fuel supply line going to the high-pressure pump.

16. In this configuration, fuel pressure measurement may be performed on the low-pressure side with the engine running.
