SI B 41 02 04  
Body Equipment

**Trunk Lid Opens Too Fast/Slow**

E60 (5 Series)

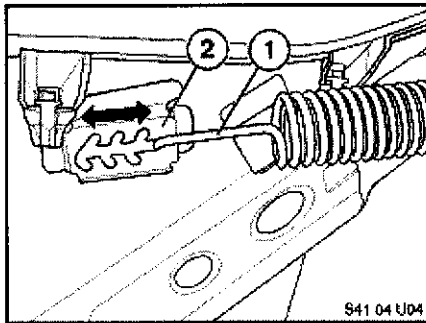
Customers may complain that the trunk lid opens too fast or too slow.

The default position for the trunk lid spring tension may not be to the customer's liking.

Remove left side trunk trim panel by following Repair Instructions 51 47 210.

Adjust trunk lid spring (1) toward the front of the adjustment block (2) to reduce the trunk lid opening speed.

Adjust trunk lid spring (1) toward the rear of the adjustment block (2) to increase the trunk lid opening speed.
