SUBJECT

Squeaking Noise from the Steering Gear

MODEL

E46 (3 Series) except M3 models

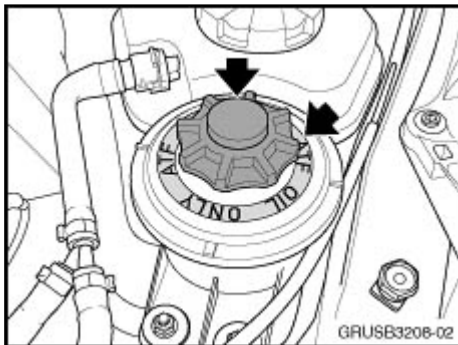
On a customer complaint basis, locate the source of the noise, using a stethoscope or other listening device. If the noise is coming from the pinion shaft area of the steering gear, proceed as follows:

1. Check the fluid level and condition of the power steering fluid. Correct the fluid level as necessary.
2. Determine whether the power steering reservoir is filled with Pentosin or ATF. Power steering systems with Pentosin will be marked on the outside of the reservoir or the cap. Additionally, Pentosin will be green in color compared to ATF, which is red. **If the system is filled with Pentosin, contact Teile Clearing for additional assistance.** If the system is filled with ATF, proceed to step 3.
