This Service Information bulletin supersedes SI B24 08 06 **dated March 2010**.

## ZF 6HP Transmissions - Mechatronic Sealing Sleeve Seepage

**NEW** E53, E60, E61, E63, E64, E65, E66, E85, E90, E91, E92, and E93 vehicles with ZF 6-speed 6HP19/21 or 6HP26/28 transmissions produced up to 04/08

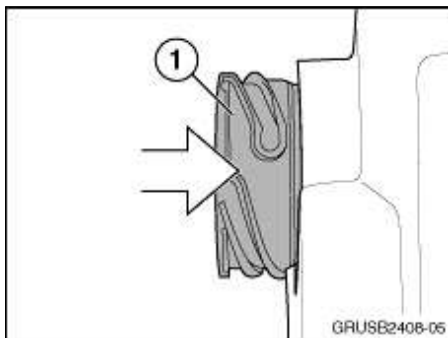
Transmission fluid seepage is visible in the area of the transmission oil pan. In most cases, only an oil "wetness" spot is spotted in the back of the transmission oil pan (the transmission fluid does not drop on the ground).

The Mechatronic sealing sleeve's O-ring tightness

**NEW** 1. Only if a visible leakage trace indicates a substantial loss of transmission fluid (e.g., transmission fluid accumulation on the underbody panel), replace the Mechatronic sealing sleeve.

**NEW** The "oil wetness" in the area of the sealing sleeve is not an indication of substantial leak, and does not justify this repair.

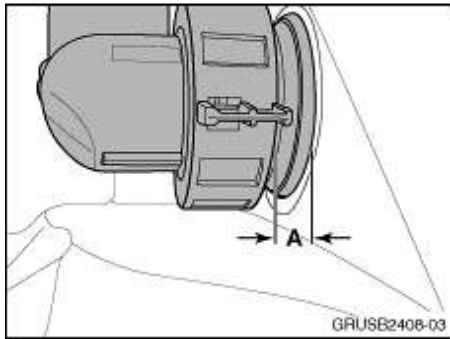
3. After installation, the correct distance between the transmission harness connector and the housing surface (B) should not exceed 3 mm.

When installing the transmission harness connector, do not use excessive force - locking of the connector should not require an increased effort. This would be an indication of an incorrectly installed sealing sleeve!!!

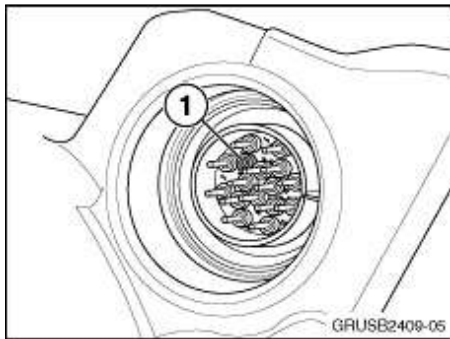
**NEW** 4. If the distance between the connector and the transmission housing (A) measures approximately 7 to 8 mm, the sealing sleeve was installed incorrectly. In such a case, an intermittent connection problem between Mechatronic and the vehicle harness connector will occur, resulting in various EGS communication faults (e.g., FC 5079 "Serial wire message missing"; FC 507A "Serial line signal plausibility"; "Gearbox Emergency Program" lamp illumination; and the transmission entering a failsafe mode).

5. In some cases, the incorrectly installed sealing sleeve may permanently damage pins in the Mechatronic connector (X8500). In such a case, the Mechatronic module has to be replaced (**pin repair is not possible**). The illustration shows an example of a broken and missing pin #4 in the X8500, caused by improper sleeve installation; this resulted in the customer's complaint about the inoperative Sport Mode of the transmission.
