Non-Return Valve Parts Found In Engine Oil Filter During Engine Oil Service

E60 (5 Series) 545i, E63 and E64 (6 Series) 645Ci and 645CiC, E65 and E66 (7 Series) 745i and 745Li, E53 (X5) 4.4i and 4.8is equipped with N62 engine

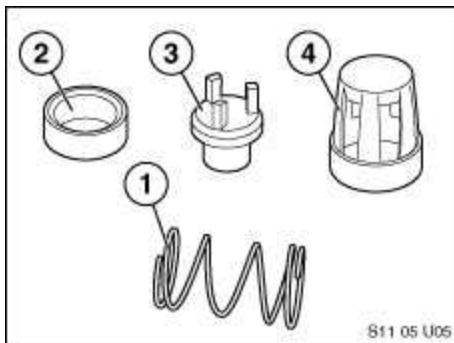
Engine Oil Pump Non-Return Valve Parts:

While performing an oil service, removal of the oil filter may reveal one or more of the following parts have dislodged from the engine oil pump. These parts make up the internal non-return valve inside the engine oil pump. The customer does not complain of loss of oil pressure while driving or does the vehicle exhibit any drivability complaints.

1. Metal Spring
2. Metal Spacer
3. Plastic Plunger
4. Plastic Cap

Note: These parts are not related to the oil pressure regulator located within the engine oil pump. The engine will not lose oil pressure while being operated.

Submit a PuMA Case to the Drivetrain Group indicating "N62 Oil Pump Parts in Filter" in the subject field. Do not release the vehicle until a response is received.
