Sport Transmission Paddle Shifters Inoperative - Diagnosis

E60, E61 with 6HP19TU, 6HP26TU transmissions and option code 2STBA

E63, E64 with 6HP26TU transmission and option code 2STBA

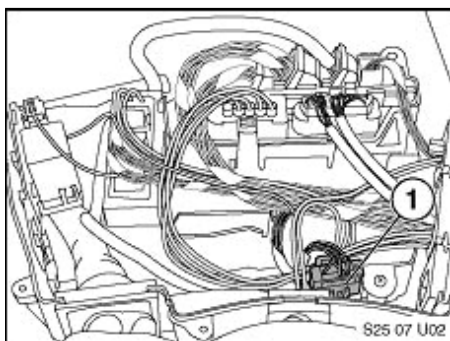
Upshift and downshift requests from both paddle shifters are transferred directly to the EGS transmission control module via a single wire connection: from the paddle shifters via SZL connector X1880, then engine connector X6031 up to the transmission control module (via Mechatronic connector X8500).

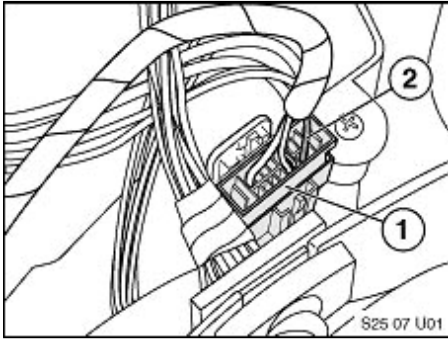
The most convenient location to monitor the paddle shifter signals is the connector X6031 (12-pin black), located inside the E-box on the front wall next to the ground harness (1).
