SUBJECT

Sport Transmission Paddle Shifters Inoperative - Diagnosis

E60, E61 with 6HP19TU, 6HP26TU transmissions and option code 2STBA

E63, E64 with 6HP26TU transmission and option code 2STBA

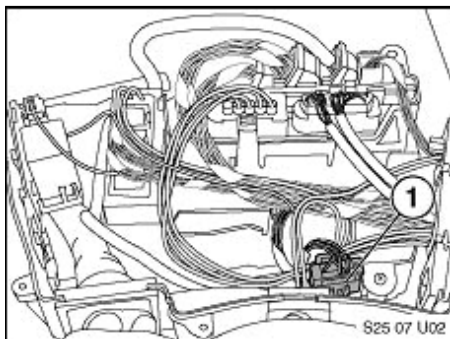
Upshift and downshift requests from both paddle shifters are transferred directly to the EGS transmission control module via a single wire connection: from the paddle shifters via SZL connector X1880, then engine connector X6031 up to the transmission control module (via Mechatronic connector X8500).
