Service Action: S85 Replace VANOS High Pressure Line

E60 M5 with S85 produced up to 11/22/05

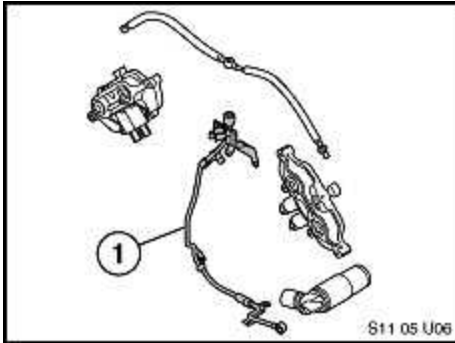
The VANOS high pressure line may start to leak engine oil around the flexible hose.

On the affected vehicles, replace the VANOS high pressure line between the pressure accumulator and connecting lead.

3. Remove the drive belt for A/C compressor (refer to TIS RA 1128050).
4. Remove the alternator drive belt (refer to TIS RA 1128010).
5. Disconnect the secondary air hose fitting and remove the water pump pulley
6. Carefully loosen the VANOS line at accumulator, to release any residual pressure, and then remove and replace the VANOS high pressure line: PN 11 36 7 838 670 – identified as #1 on the illustration.
7. The required tightening torques can be found in TIS under: 11 36 Variable camshaft control. All sealing rings must be replaced.

Important: Only copper sealing rings must be fitted.
