This Service Information bulletin supersedes SI B61 13 06 **dated February 2009.**

Various Electrical Problems Caused by Water Ingress

E60 (5 Series)

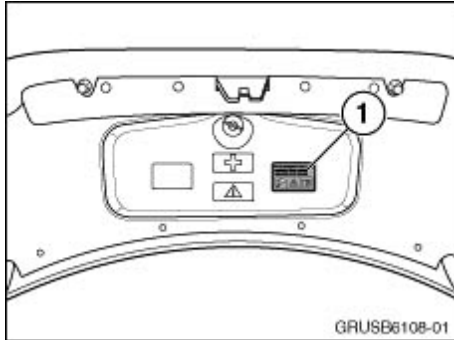
- a. Relocate the RDC module to the left-hand side of the trunk per Repair Instruction RA 36 11...
- b. **NEW** Relocate both the SDARS and PDC modules, if so equipped, per the attached repair procedure **SI B61 13 06 Procedure.pdf**.
- c. In the bottom of the trunk are 4 stamped openings in the sheet metal which are filled with seam sealer. Drill a 1-2mm one hole through the center of each of the forward 2 stamped openings only.

NOTE: The drilled holes should only penetrate the seam sealer and not the steel floor pan.

- d. Install a warning label (PN 71 24 6 777 721) on the right side of the tool kit cover (1). The customer should be notified of the label and the fact that liquids should not be present on or under the trunk insulation, due to the sensitive nature of the electronic control units located in the spare tire well.
