SUBJECT

Remote Control Malfunction or Radio Reception Problem

MODEL

E61 (5 Series Sports Wagon) produced up to 1/2008

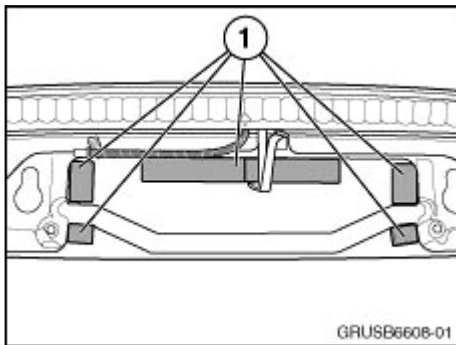
The diversity antennae located under the rear (tailgate) spoiler may have been water-damaged due to the spoiler and the antennae trim not fitting properly.

6. Install the 5 new foam spacers (1) to the areas identified in the illustration.
