This Service Information bulletin supersedes SI B54 06 06 **dated November 2006**.

Water Leak from Panoramic Sunroof

NEW E53, E70 (X5)

E61 (5 Series Sports Wagon) Absorbent Pad Kit Installation

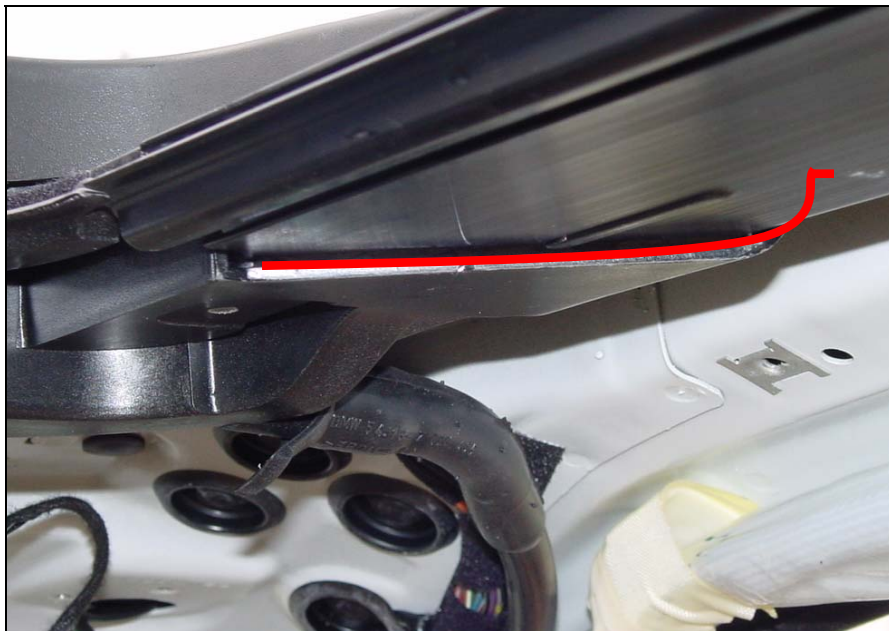
Sealing Side Seams

- Water may leak from the seam shown; where the side rail of the cassette meets the front section.
- Apply a bead of sealant, such as Sika-flex, along the complete length of the joint.
- This procedure should be performed for both the right and left side of the cassette.

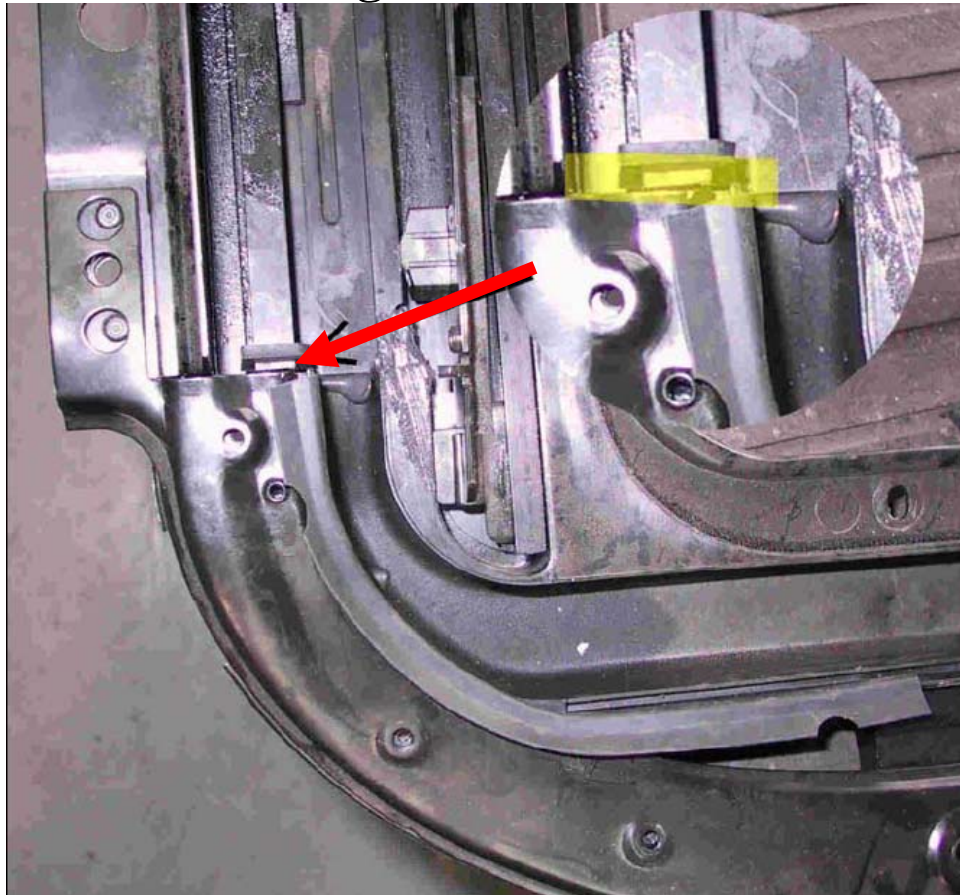
Sealing Cable Channels

- Water may enter the cable channel through the area shown.
- With the cassette removed from the vehicle, seal the gap shown to prevent water from entering the cable channel.
- Apply a small amount of sealer, such as Permatex “Right Stuff”, or equivalent silicone sealer, to the gap.
- **Note:** Apply the sealer carefully as not to contaminate the cable itself with sealer, or obstruct the water’s path as it flows past this area.
- This procedure should be performed for both the right and left side of the cassette.
