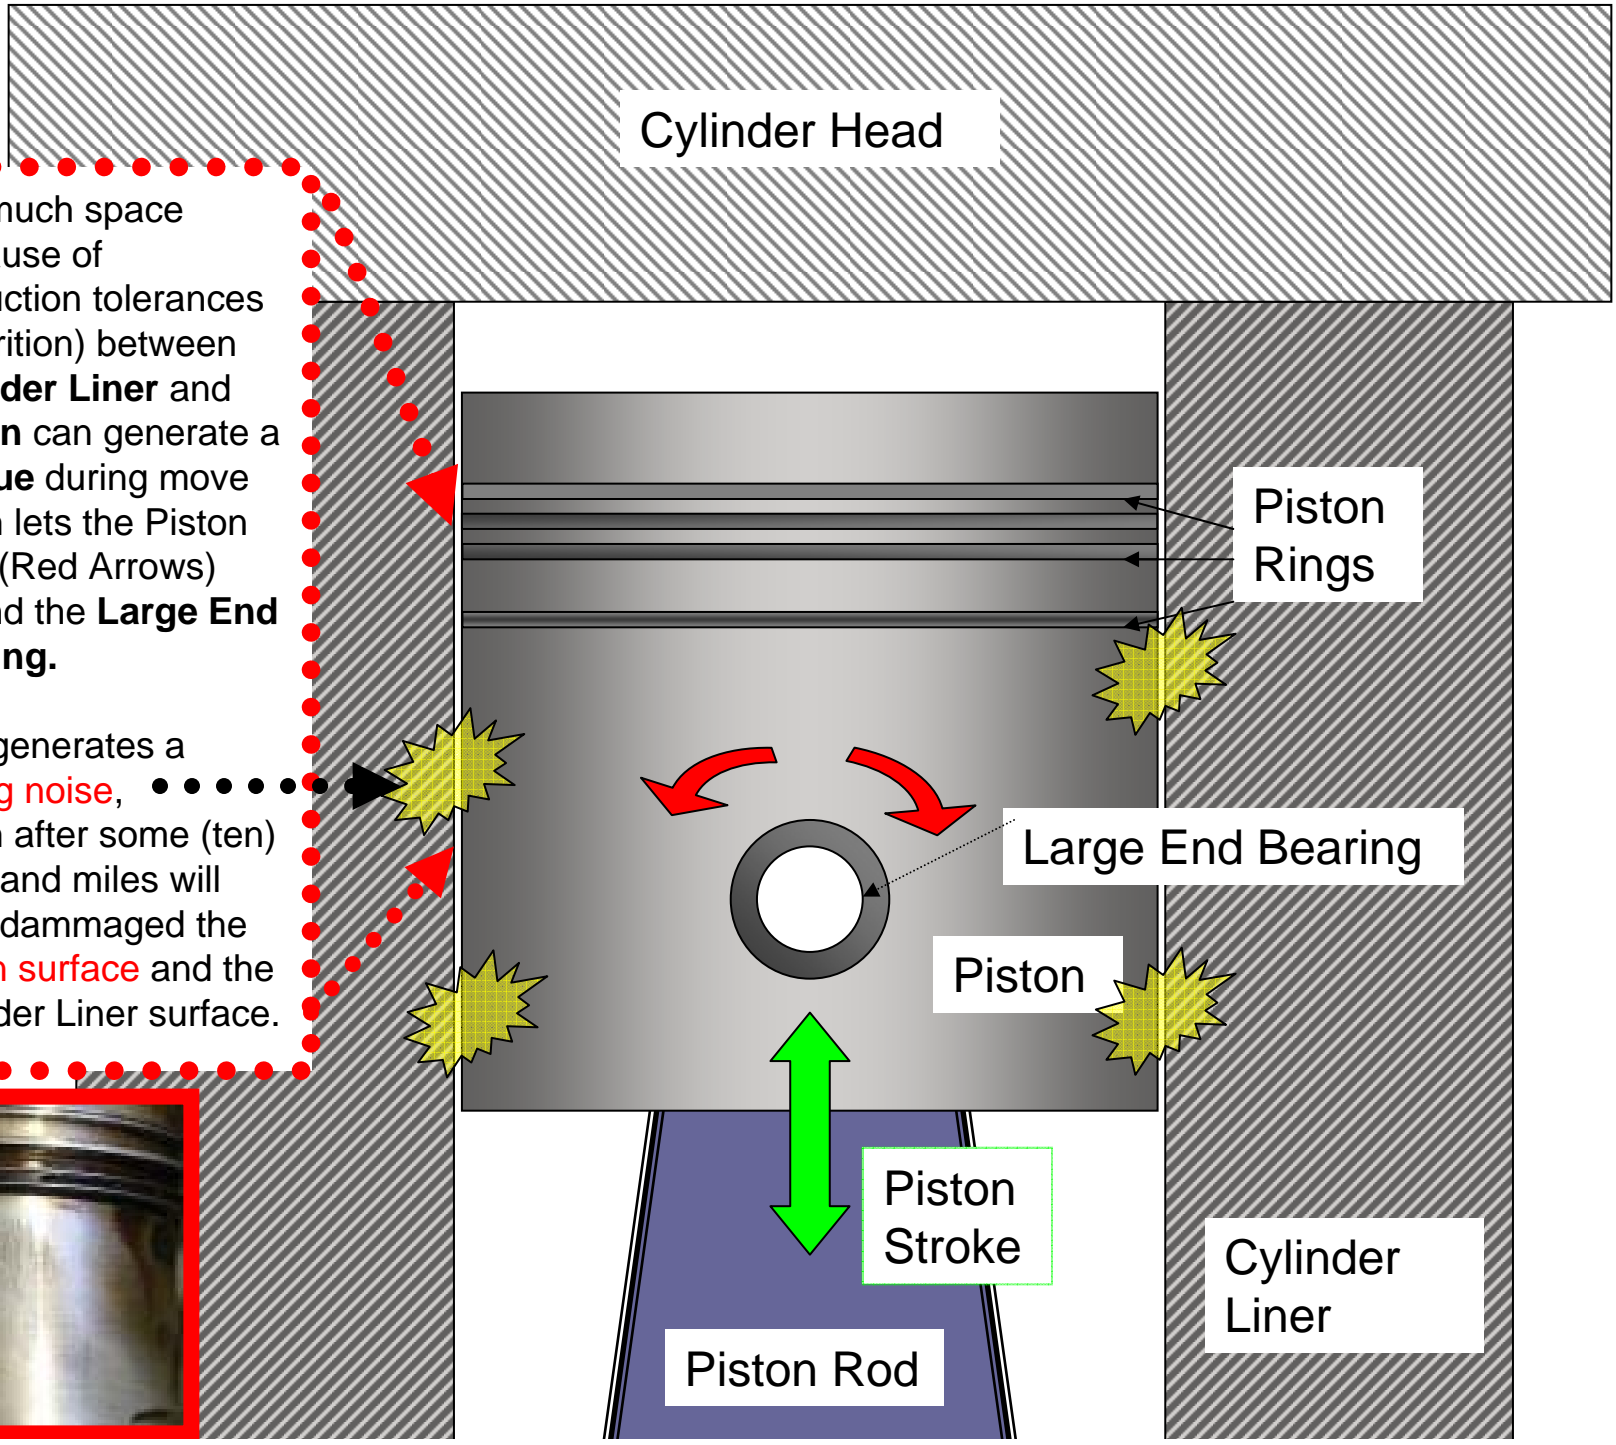
Too much space (because of production tolerances or attrition) between **Cylinder Liner** and **Piston** can generate a **Torque** during move which lets the Piston pivot (Red Arrows) around the **Large End Bearing**. This generates a **ticking noise**, which after some (ten) thousand miles will have damaged the **piston surface** and the **Cylinder Liner surface**.
