BMW Poor Radio Reception DIY Repair, AM and FM, E46 3-Series and Other Models

SEPTEMBER 8, 2011

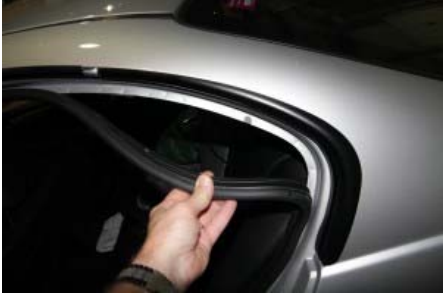
1) On the driver side (left side): Pull back the door gasket, along the C-pillar.

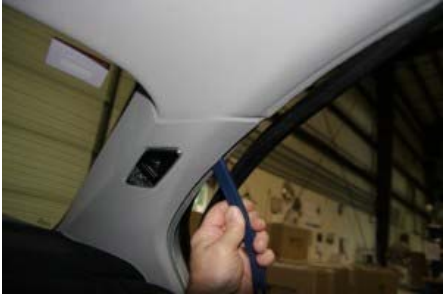
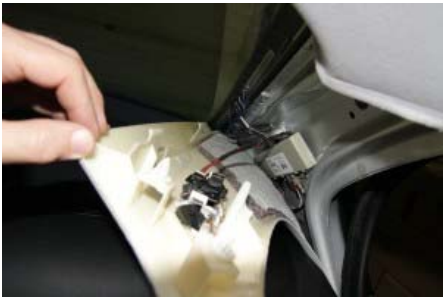
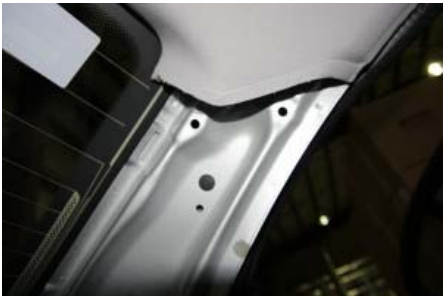
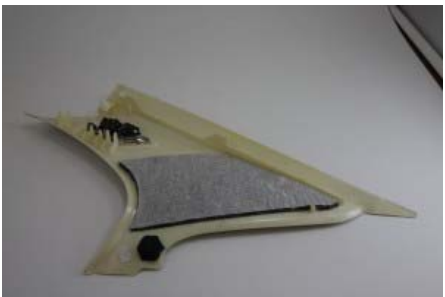
2) Use a non-marring pry tool to pry the C-pillar trim cover loose. There are two clips at the upper end of the cover (see the following photos). Unplug the light harness plug and then pull the cover upward to fully remove it.

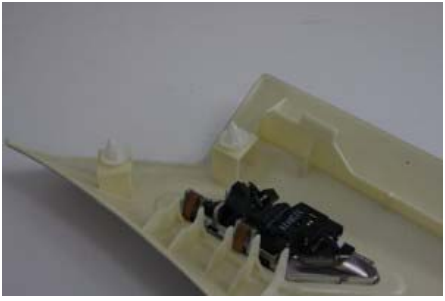
3) You now have access to the antenna amplifier and the window grid connections.

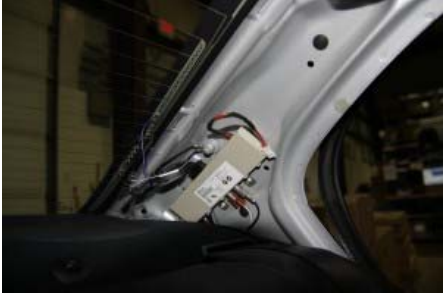
4) Unplug and remove the window grid connector harness.

There is one snap clip at the upper end of the window grid harness plug. Carefully pry the clip away and push the plug assembly upward to remove.

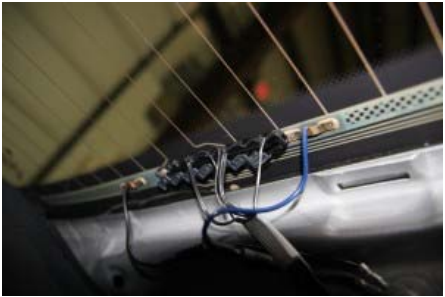
Connector plug on window with harness plug removed.

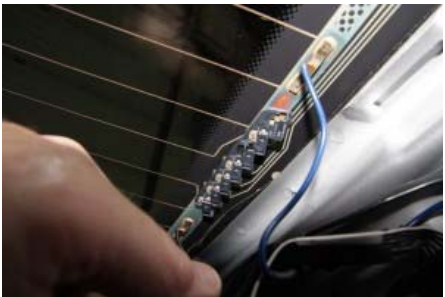
Window antenna harness plug. Clip is show at pinky finger.

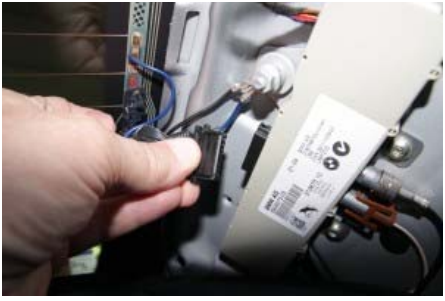
Window harness removed.

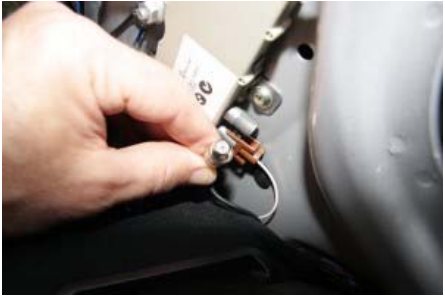
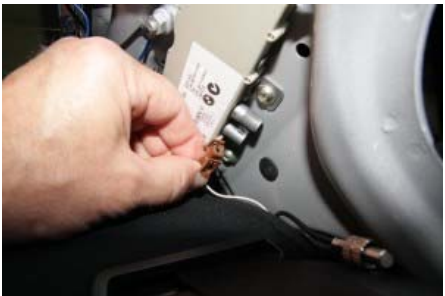
5) Apply the DeoxIT drops to each terminal connection on both ends of the window harness and each of the antenna and power terminals.

The oxidation of the contact terminals is a progressive issue. At initial assembly, all is fine. As the vehicle ages, the electrical contact terminals oxidize and this reduces the electrical contact. The radio antenna signal is very low voltage and current. Therefore it is quite susceptible to interference due to the oxidation.

The DeoxIT will not only clean the terminals, but it leaves a protective coating to prevent future oxidation or corrosion.

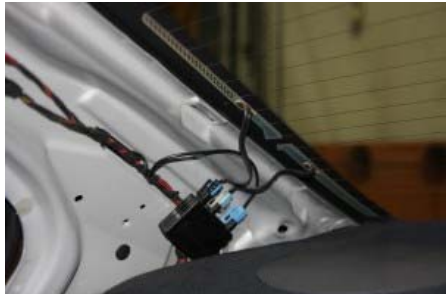
7) There is another unit under the passenger side (right side) C-pillar. This is a radio frequency trap, or filter. Perform the same work with the DeoxIT on this unit.
