# RELOCATING THE MULF

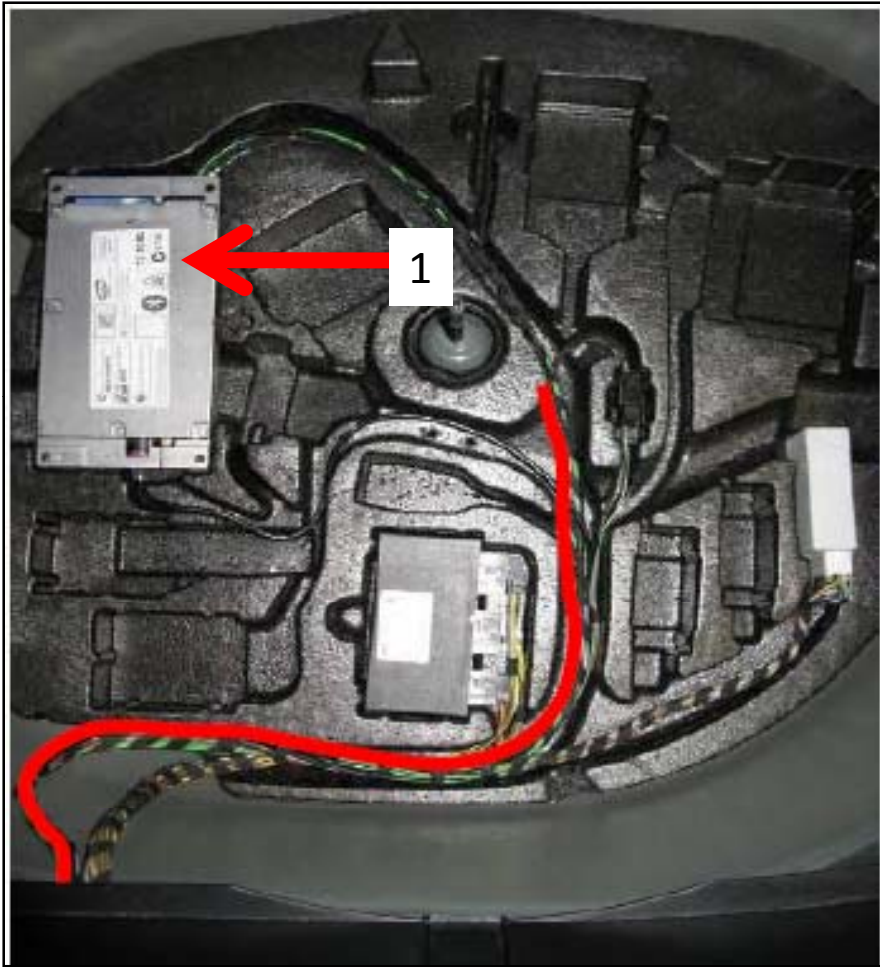
1) Remove the trim panels from the left and right side of the luggage compartment per Repair Instruction REP 51 47 210/220 and remove the tail panel trim.

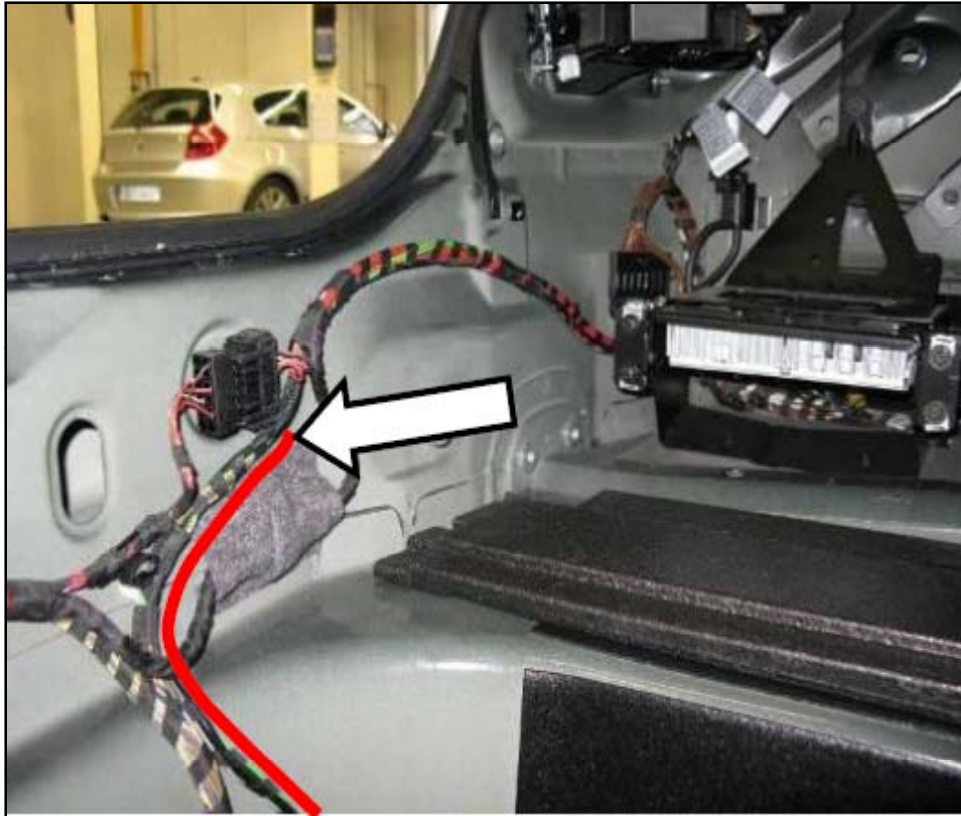
2) Remove the MULF (1) and pull the wiring harness back along the red line.

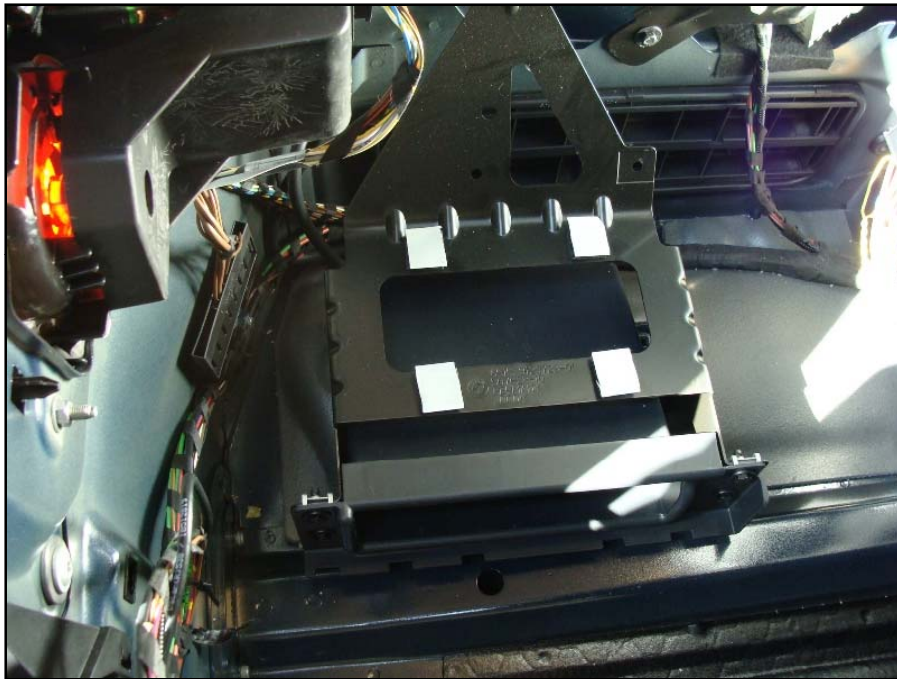
3) Continue pulling back the harness along the red line to the point shown by the arrow.

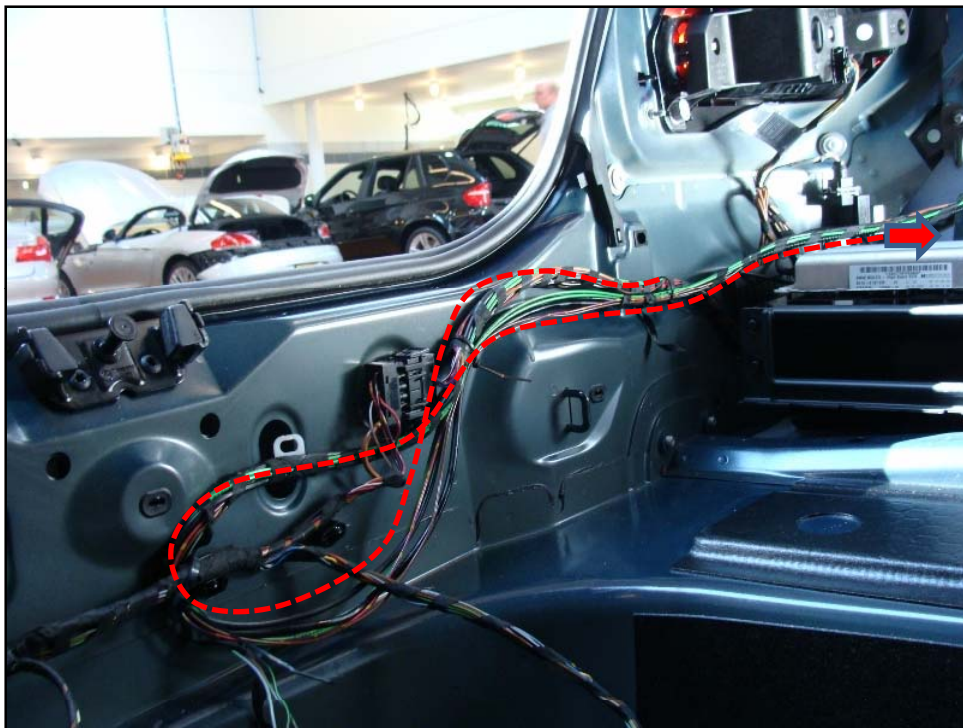
4) Secure the hook side of 2 pieces of Velcro to each other. Repeat 3 more times (using 8 pieces of Velcro in total). Peel the backing off one side of each Velcro pair and secure each to the bracket in the left side of the luggage compartment, as shown.

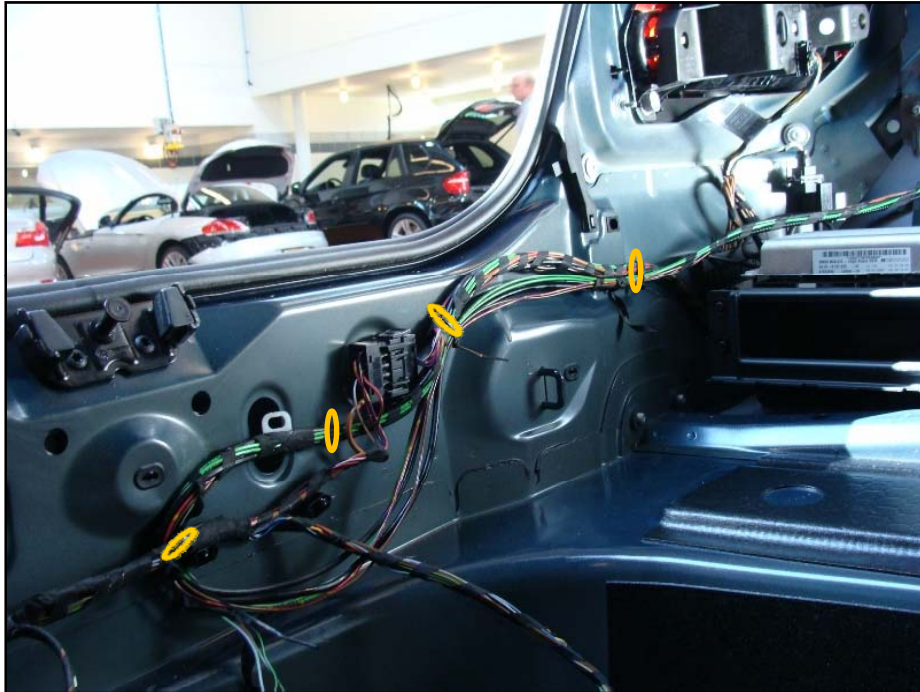
5) Route the harness for the MULF in a loop on the tail panel, as shown. This way, the harness will not have excess slack in it, and will allow the MULF to sit on top of the bracket in the left side of the luggage compartment.

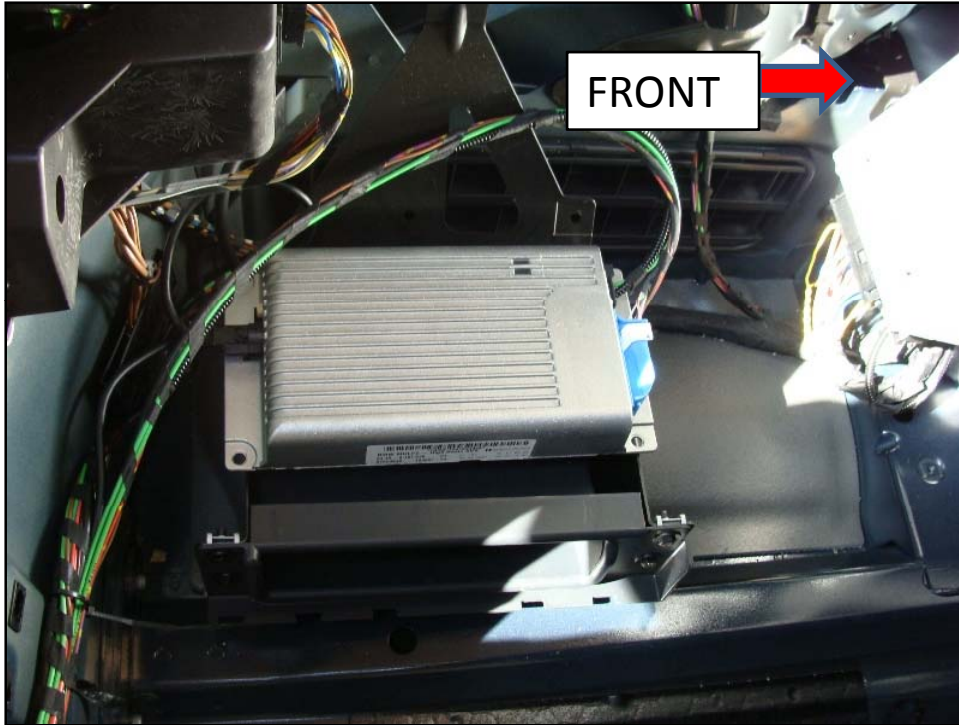
6) Secure the harness in its new position, using 4 wire ties.

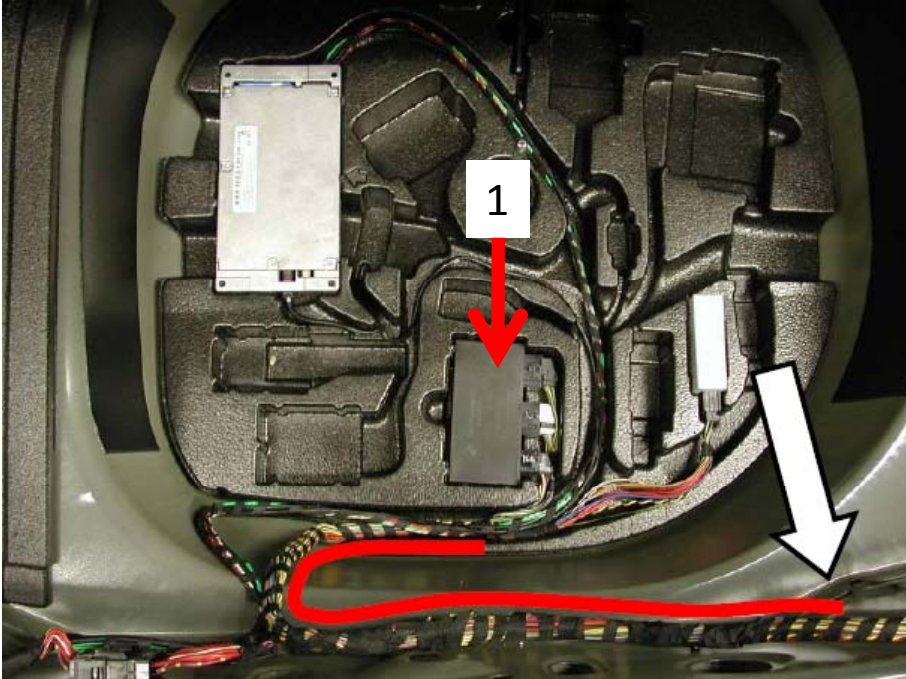
1) Remove the PDC Module (1) and pull the wiring harness back along the red line to the point identified by the arrow.

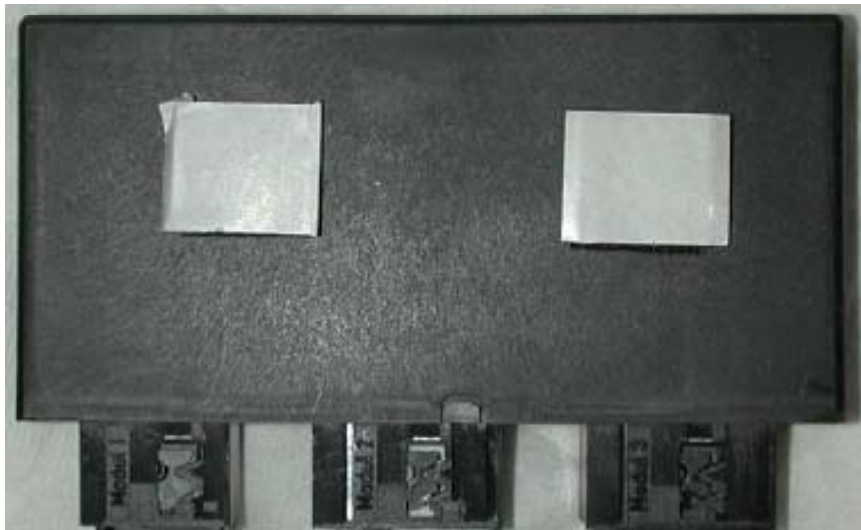
2) Secure the hook side of 2 pieces of Velcro to each other. Repeat once (using 4 pieces of Velcro in total). Peel the backing off one side of each Velcro pair and secure each to the back side of the PDC module, as shown.

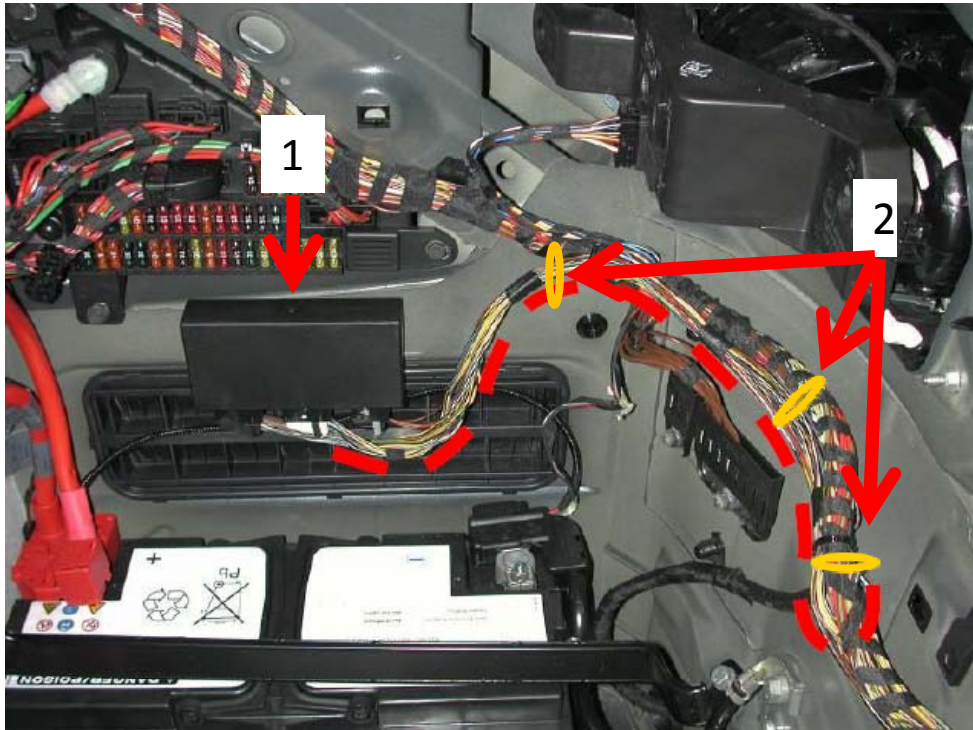
3) Route the PDC module (1) back along its own wiring harness to reach the point above the middle of the right side air extractor. Peel the backing off of the Velcro pads and secure the PDC module to the body structure. Secure the wiring harness with 3 wire ties (2). Replace any panels that have been removed.
