Check A/C Condensate Drain Hose on E60, E61, E63, and E64 vehicles.

TEST PROCEDURE

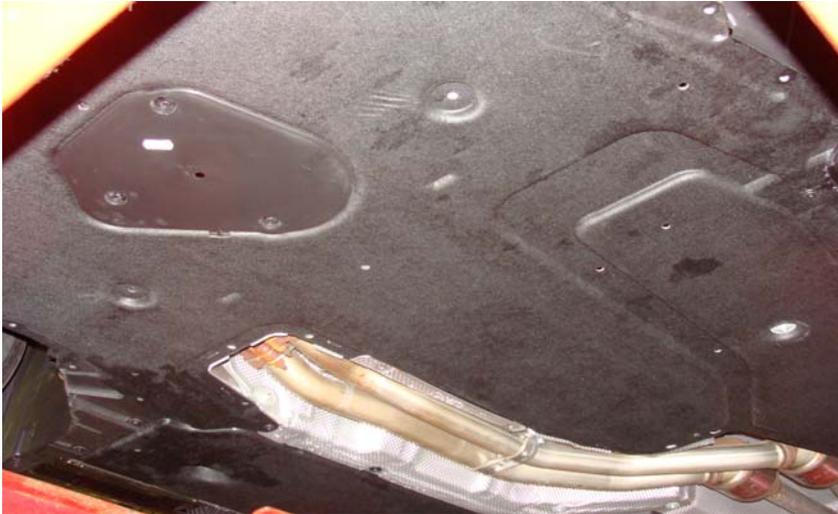
1. Position the vehicle on a lift (or over a pit).

Remove the vehicle underbody around the transmission; see Repair Instruction REP 51 47... "Removing and installing /replace the rear assembly underside protection".

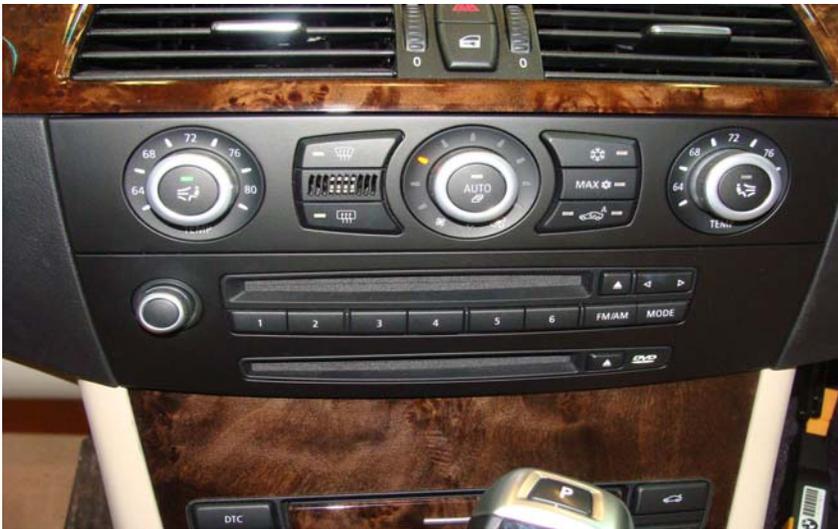
2. Switch Terminal 15 on. Turn on the air conditioner and set the blower to minimum.

Deactivate the recirculated-air mode to open the fresh air flaps.

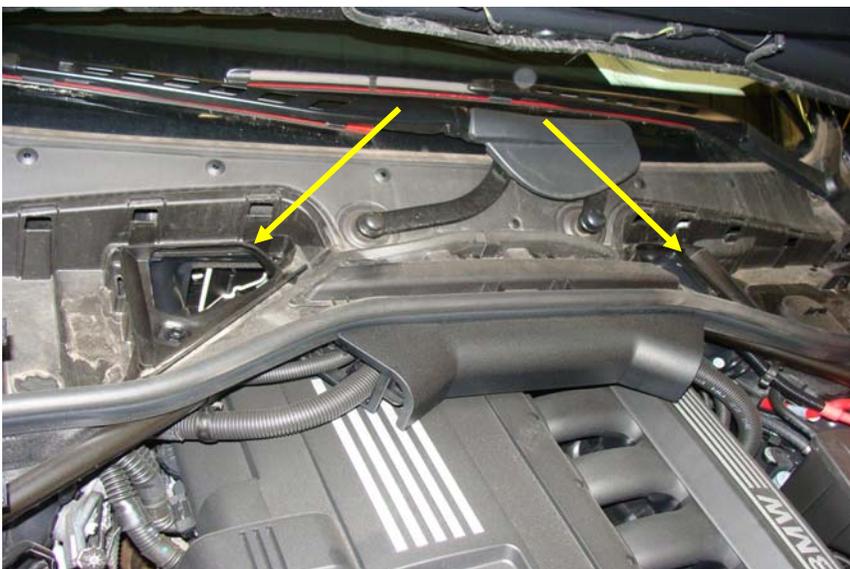
3. Remove the two covers from the microfilter housing. The fresh air flaps are now visible.

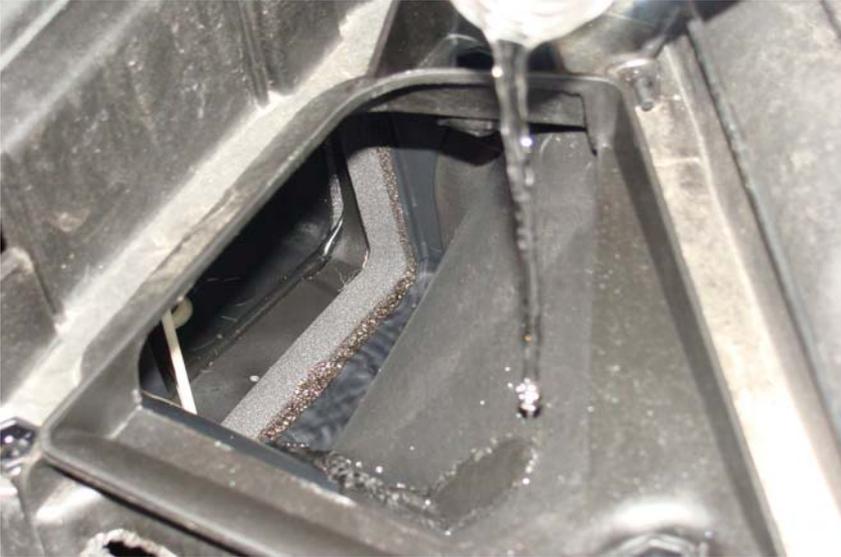
4. Pour a maximum of 250ml of water behind the fresh air flaps onto the sloping wall of the air conditioning housing, as shown.

Note: This must be done on both sides. Test one side at a time.

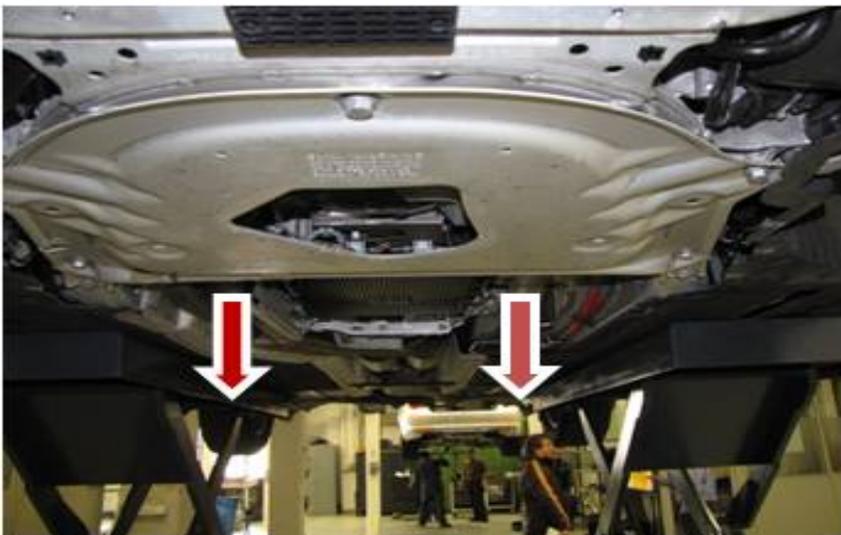
5. After a short delay (approx 10 - 15 secs), the water must flow out of the condensate drain hoses attached to the vehicle's underbody.

Note: If no water is flowing out from the condensate drain hose on the same side into which the water was introduced, the connecting piece is blocked and must be replaced.

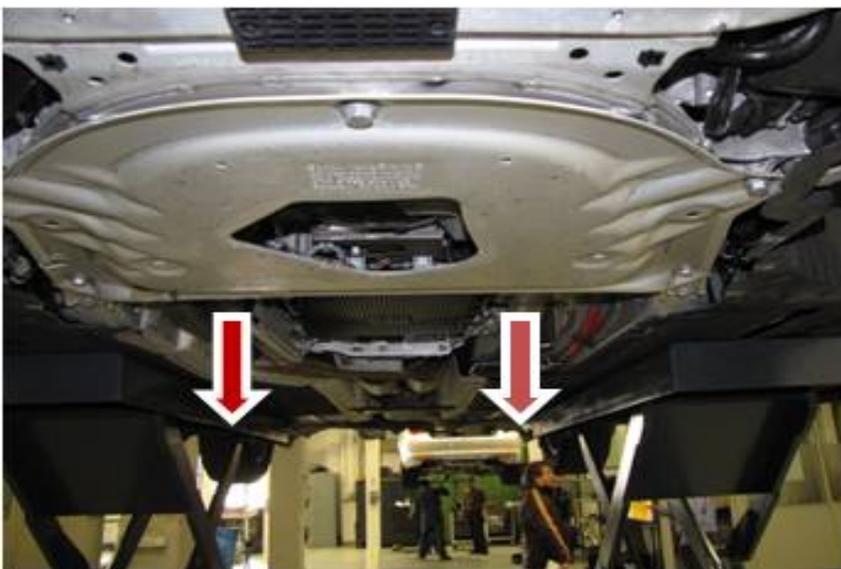
6. If no water flows out of either side, both condensate drain hoses are blocked and must be replaced.

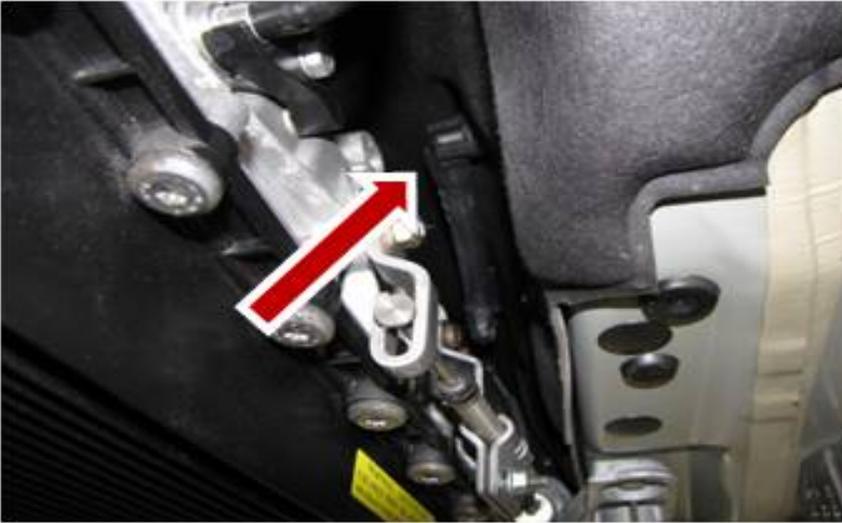
Note: Driver's side is shown below; passenger side is similar.

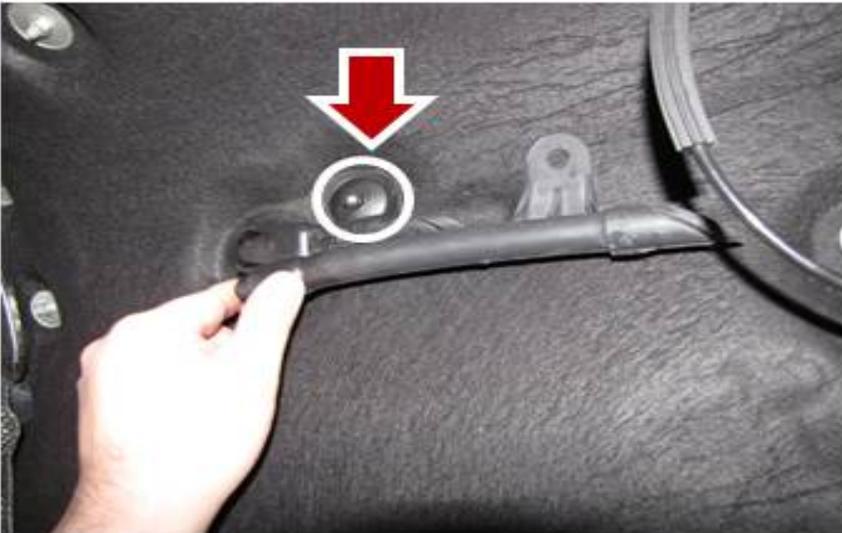
10. The photo shows the condensate drain hose on the 528i driver's side (left)..

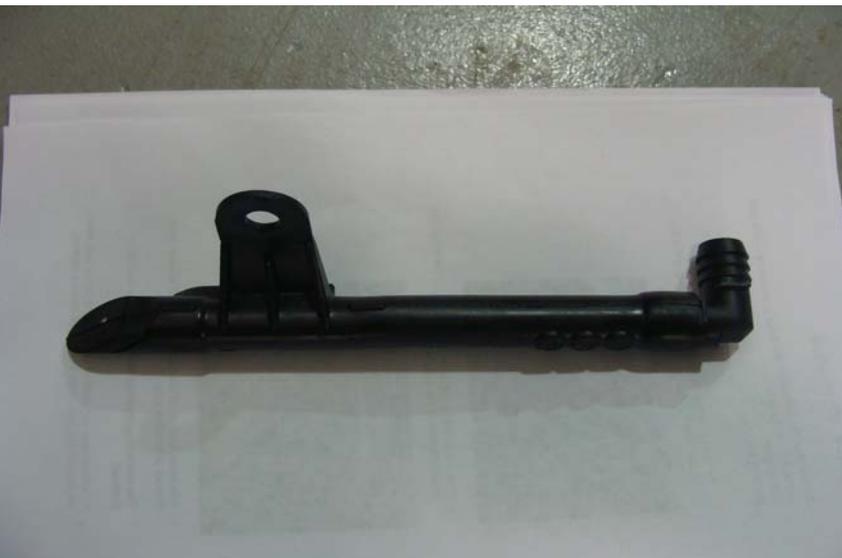
Note: The condensate drain hoses are secured with a plastic nut (wrench size 10mm) as shown in photo.
