RELOCATING THE MULF

RELOCATING THE PDC Module

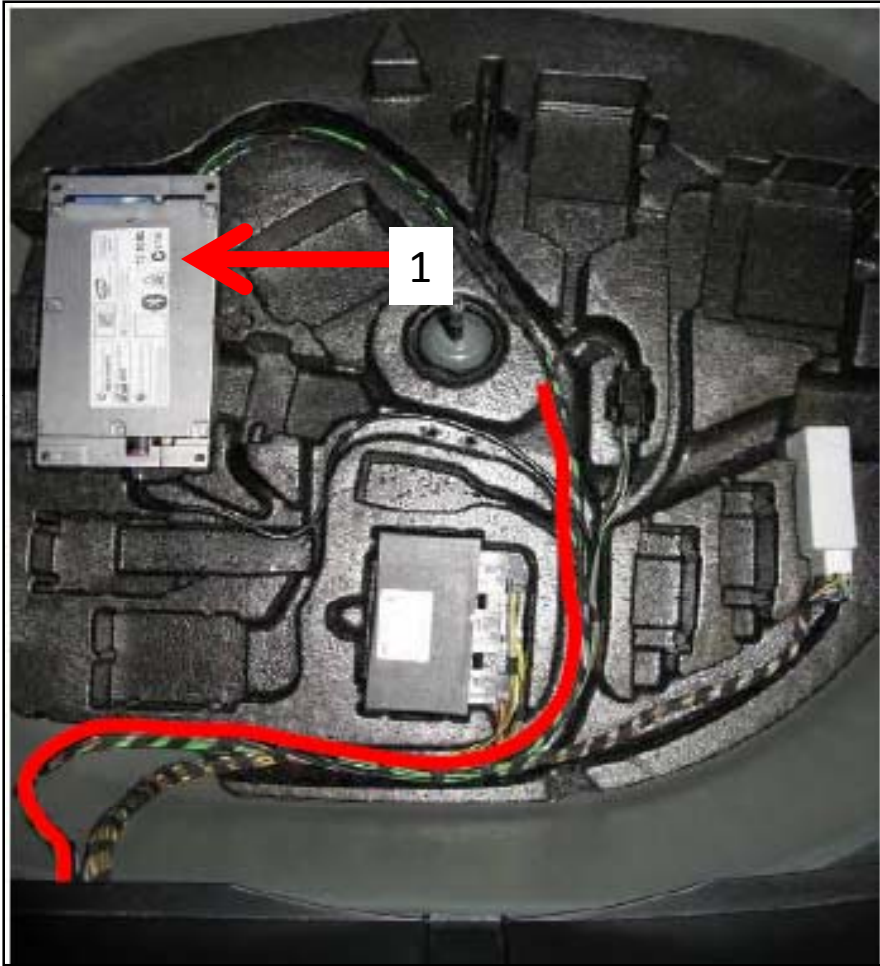
1) Remove the trim panels from the left and right side of the luggage compartment per Repair Instruction REP 51 47 210/220 and remove the tail panel trim.

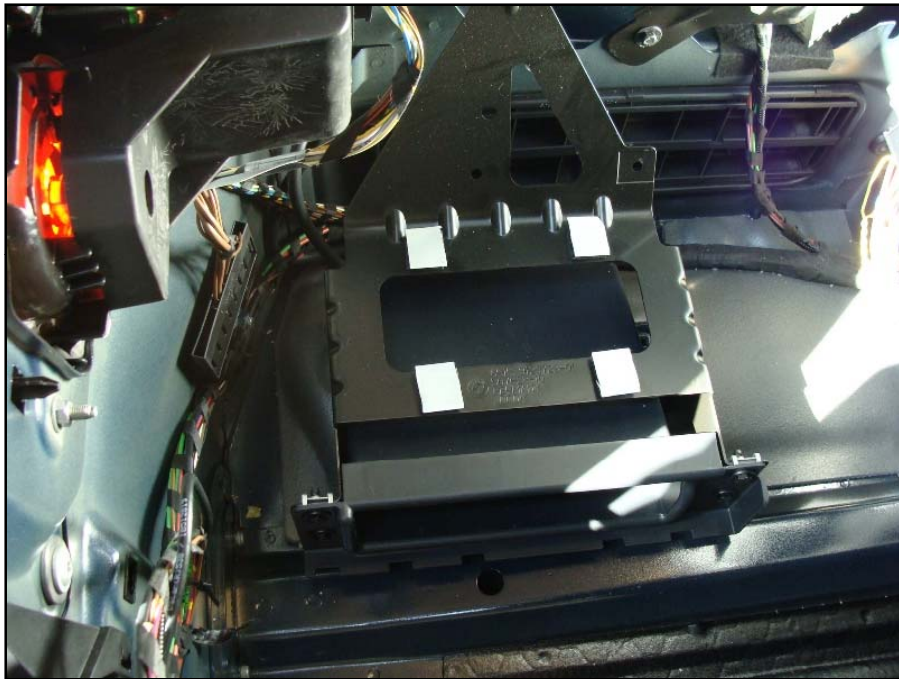
3) Continue pulling back the harness along the red line to the point shown by the arrow.

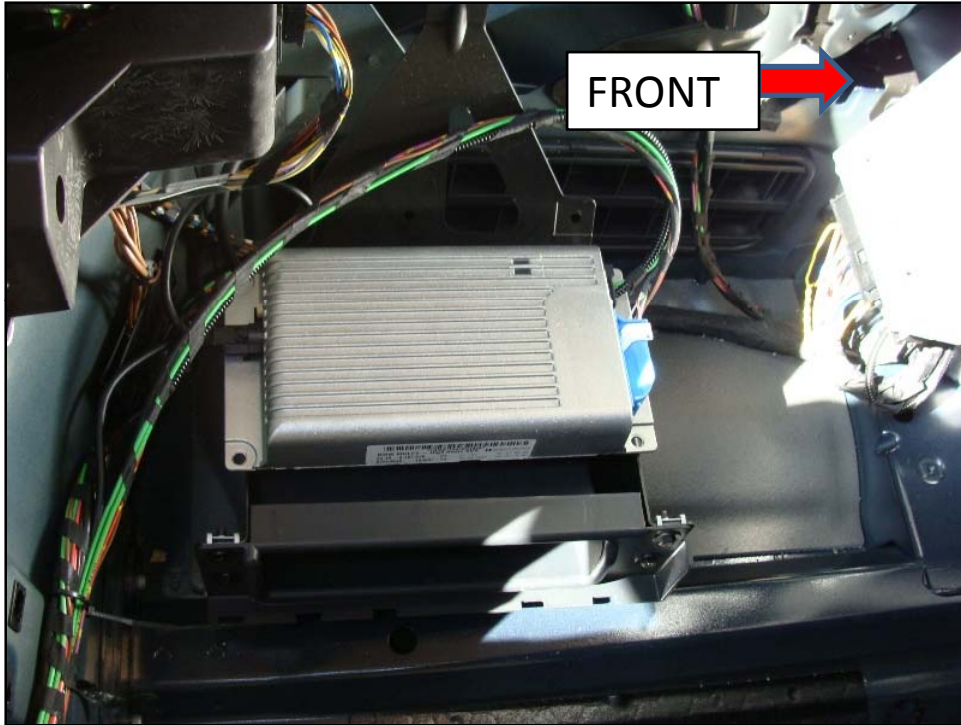
6) Secure the harness in its new position, using 4 wire ties.
