How to replace micro switch on rear glass BMW E61

Fault indication: glass open by itself or is not possible to open at all.

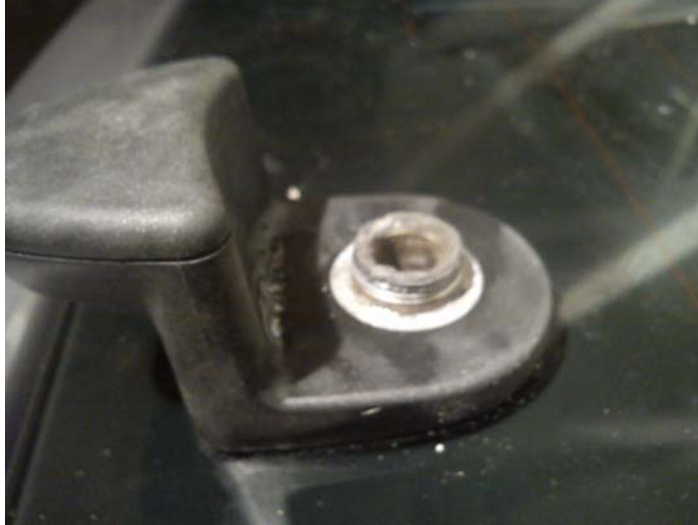
Now comes the tricky part...if the button is not possible to move it is corroded on the axis and you will have to use the Dremel-tool and cut the switch into pieces. This was my case.

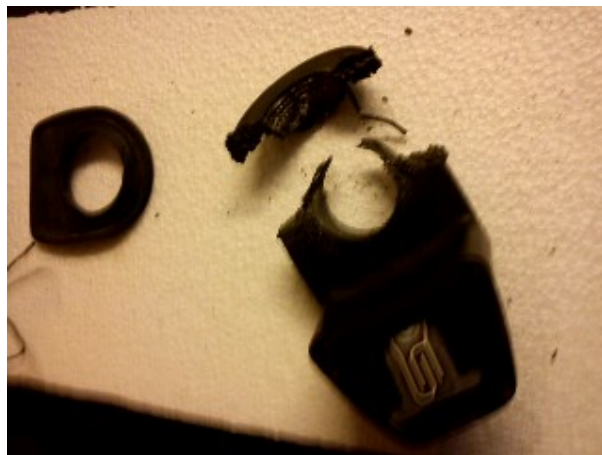
3. Protect the glass and use the dremel-tool. Make a cut on both sides and bend/pull of the plastic part of the micro switch. Cut the cables. Don't cut in the glass...it will crack=expensive!

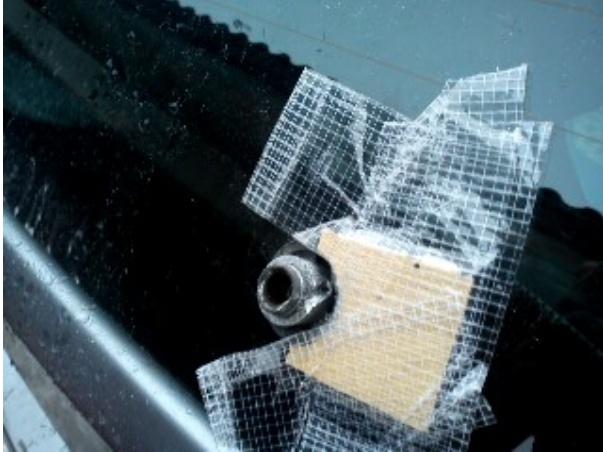
4. No comes the most tricky part. The metal washer is still on the axis...protect the glass and make a cut with the Dremel-tool. In my case I used tape and a piece of wood to protect the glass.

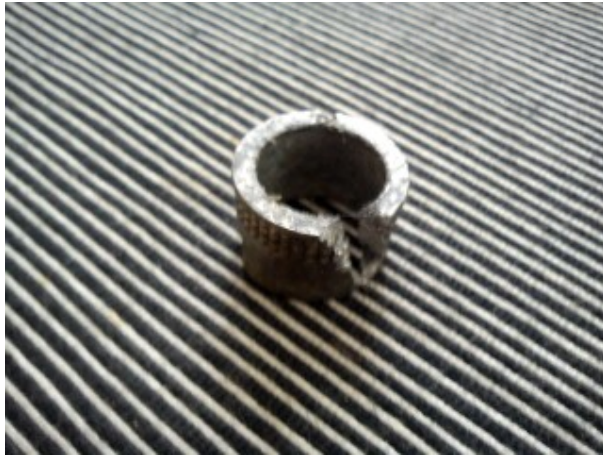
5. Be sure that the cut made by Dremel is all the way down and now use a flat screw driver to “open” the metal washer to take it off the axis.

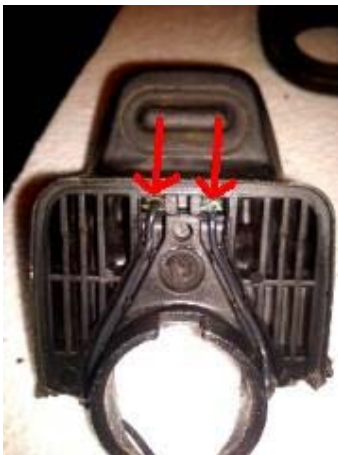
Poor sealing between micro switch housing and glass plate. The water comes through the cable inlet according to red arrows below.

Micro switch housing is very sensitive for water. This type of switch is normally used in cheap indoor applications like a keyboard for a table calculator or a remote control. Poor quality as usual=BMW.

The new switch will last for maybe 4 years then it's broken again..a recommendation is to cover this switch when you wash the car to don't get water inside.
