RELOCATING THE MULF

RELOCATING THE PDC Module

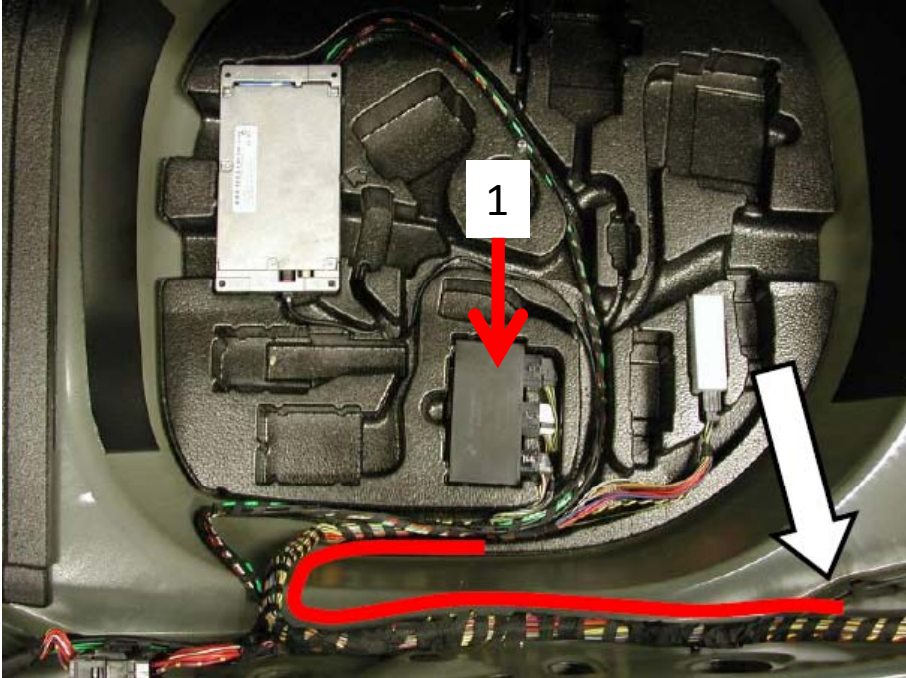
1) Remove the PDC Module (1) and pull the wiring harness back along the red line to the point identified by the arrow.

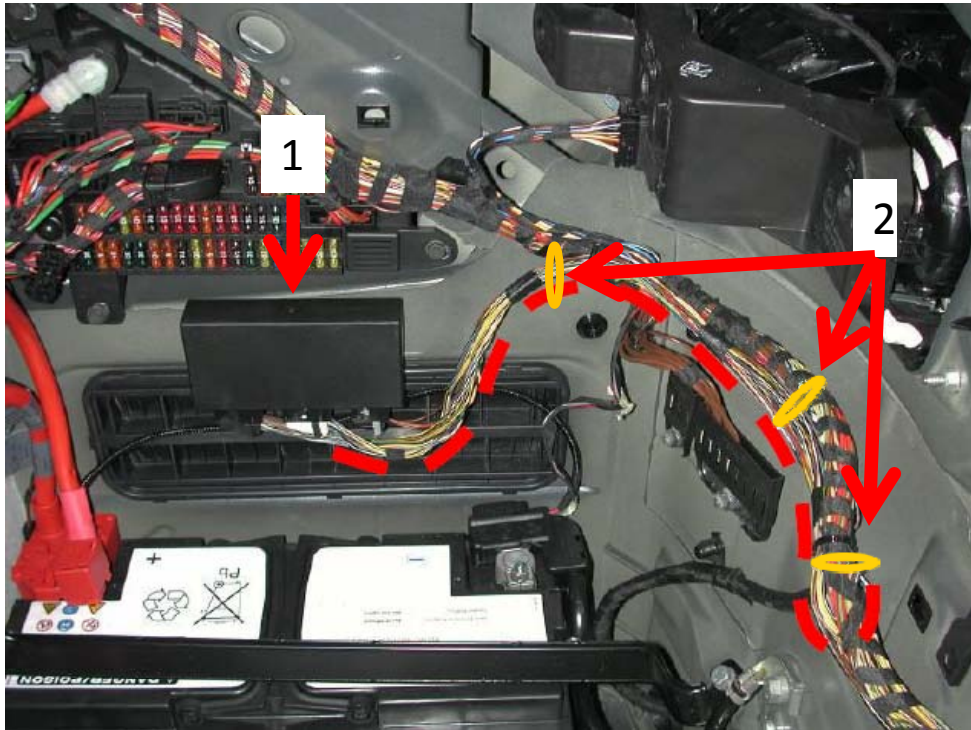
3) Route the PDC module (1) back along its own wiring harness to reach the point above the middle of the right side air extractor. Peel the backing off of the Velcro pads and secure the PDC module to the body structure. Secure the wiring harness with 3 wire ties (2). Replace any panels that have been removed.
