SIB 11 01 22

2022-08-22

RECALL 22V-119: POSITIVE CRANKCASE VENTILATION (PCV) BLOW-BY HEATER

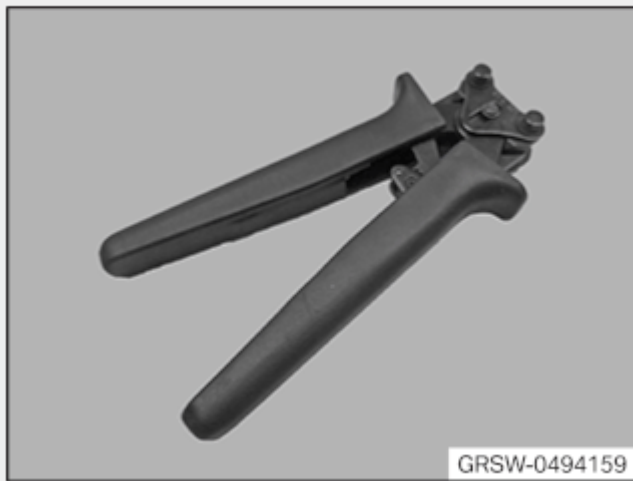
0 494 159 (61 4 321) Handle

Handle 83 30 0 494 159 (61 4 321) was distributed in the Crimping Set P/N 83 30 0 494 158 via the Automatic Tool Shipment Program in 2001.

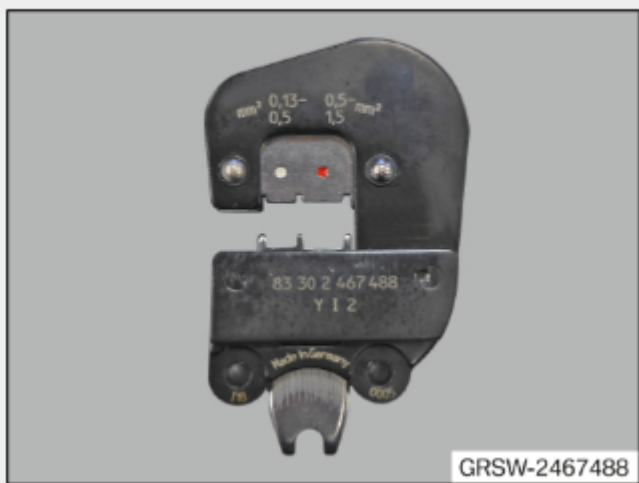
2 467 488 Crimping tool

Crimping tool 2 467 488 was shipped via Automatic Tool Shipment in late June 2022.
