Thank you for your purchase. Read this document THOROUGHLY before starting. Read it twice or thrice!

Implementation of MP3 Capability

CCC: MP3 CD Playback Not Available

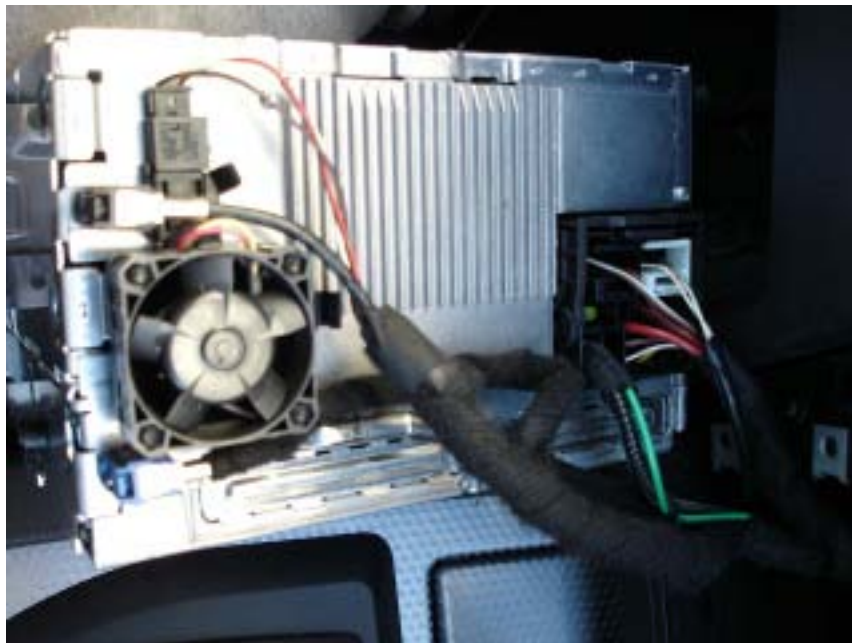
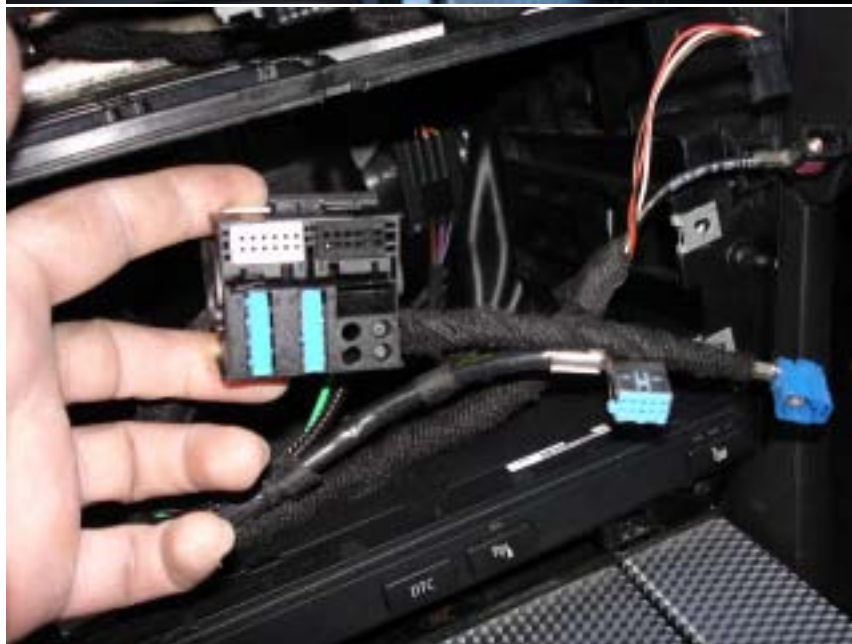
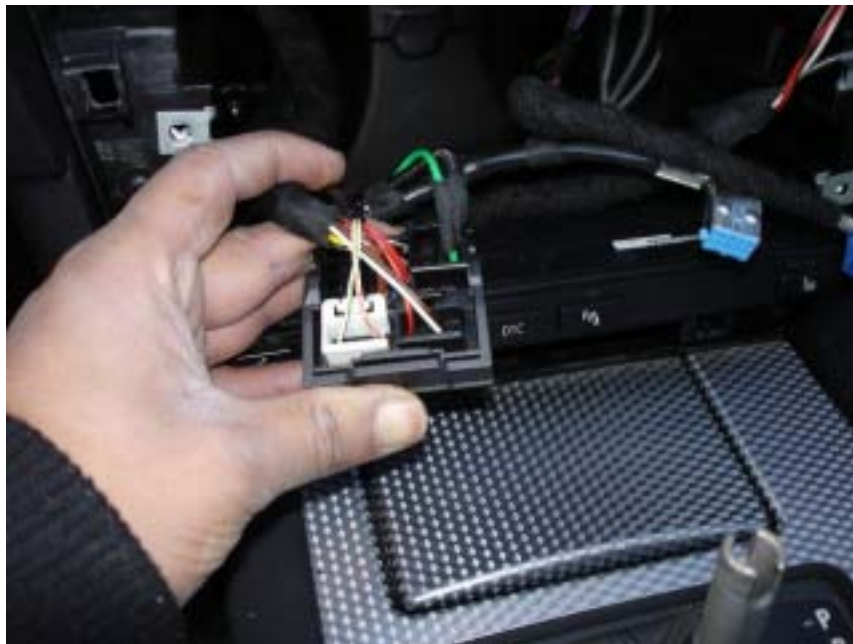
Decide where you would like to put your new jack. Most people slide it into the glovebox. Do so at this time leaving a little play so that you can still maneuver the harness X13812. After you have the cable routed to your desired location secure this aux cable to your wire harness with the provided wire tie.

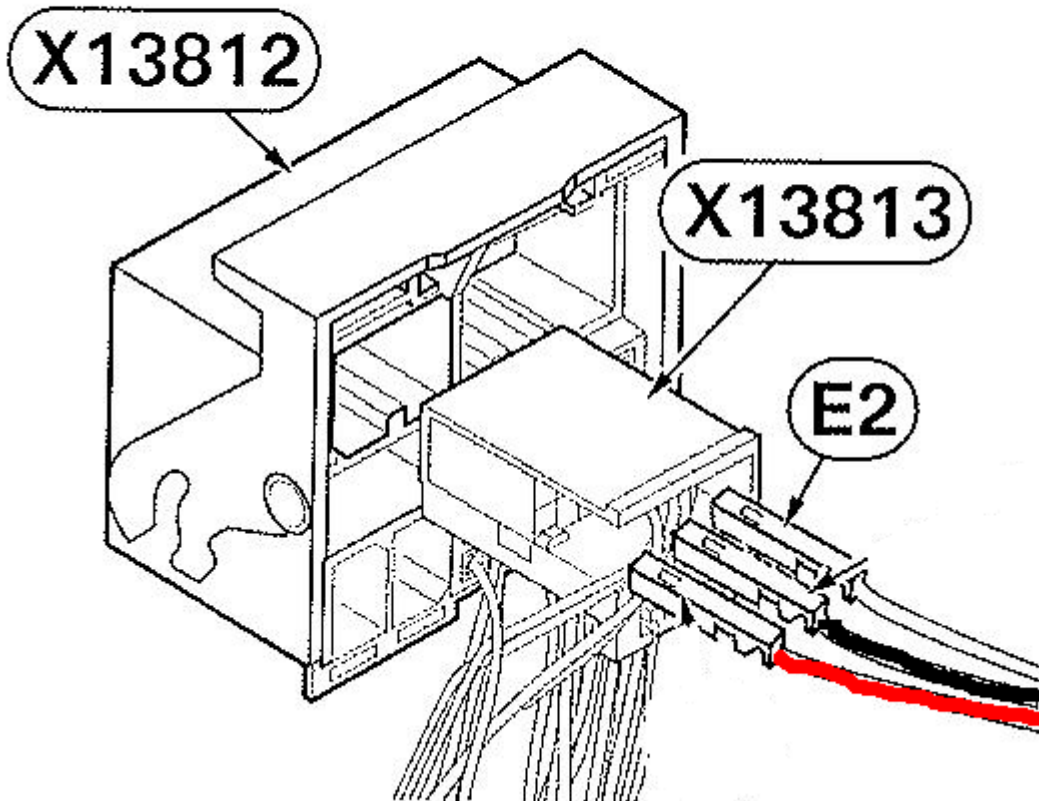
The pinout is as follows below. If you look closely the numbers of the pin are on the front of the harness.

[10] [9] [8] [7] [6]
 [1] [2] [3] [4] [5]

RED = Right + (to pin 7) WHITE = Left + (to pin 2) Black = Ground – (to pin 8)

After removing the stereo completely you can now work on the harness. Remove plug X13813 from X13812. Install the connectors to X13813 per the pinout below. Install X13813 into X13812.

On the connector are little numbers. Read the number and connect the colors to the pins below. If you mess up it may be difficult to push the connector out to switch it to another port. Connectors should slide in. You may have to push them to make sure they're tight. If you've messed this up and ended up sliding the connector out of the port, you may need to use a little superglue to make sure the connector is seated tightly. This glue is very thin and can easily run. Do not squeeze the bottle! Just dab it until you see a little glue has made contact. Allow to dry for 5- 10 minutes.
