Service Action: Telematics Control Unit (TCU) – MOST-bus Vehicles

E60, E61 (5 Series) from 7/03 to 2/06 production

SITUATION

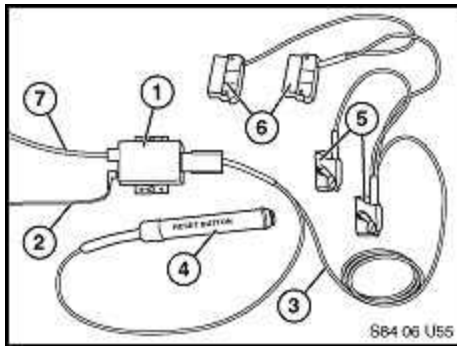
MOXA Kit comprises of:

- MOXA box (1)
- Power cable (2)
- MOXA cable (3) with:

- Reset button (4)
- TCU connectors (5)

- The **blue** connector is for E60, E61, E63, E64, E90, E91 vehicles.
- The **black** connector is for E46, E53, E65, E66, E83 and E85 vehicles.

- Power cable (2)
- Work shop LAN cable (7)
- MOXA Cable (3)

- Disconnect the vehicle TCU connector.
- Connect MOXA connector (6) to the vehicle harness.
- Connect the MOXA connector (5) to the vehicle TCU (the TCU need not be removed from the vehicle).

NOTE: The remaining unconnected connectors (5) and (6) must not be connected together, or the procedure will fail.

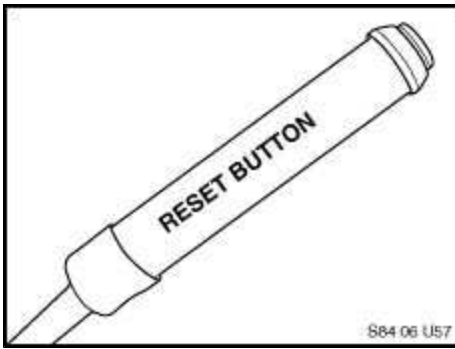
20. When requested, press the "Reset" button for a **minimum of 5 seconds**, then select "Continue".

- You will be requested to press the "Reset" button on up to **four** separate occasions.

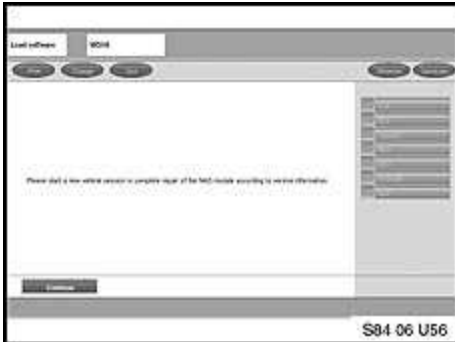
- The session will time out after 15 minutes if the "Reset" button is not pressed when requested. Performing the programming overnight will fail because the "Reset" button needs to be pressed for the process to complete successfully.

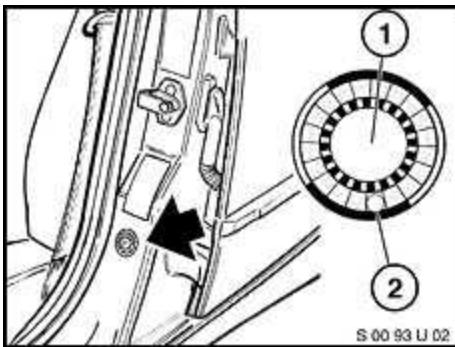
LABEL INSTRUCTIONS

This Service Action has been assigned code number **473**. After the vehicle has been checked, and corrected if necessary, obtain a label (SD 92-295) and:

- Emboss your BMW dealer warranty number in the middle of the label (1);
- Punch out code number **473** printed on the label (2) and,
- Affix the label to the **B** pillar as shown.
