Service Action: Telematics Control Unit (TCU) – MOST-bus Vehicles

MODEL

E60, E61 (5 Series) from 7/03 to 2/06 production

E65, E66 (7 Series) from 9/02 to 3/06 production

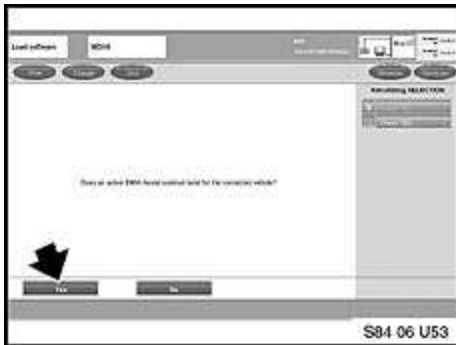
5. Select "**Check TEL**" in the Retrofit menu.

6. Follow the on-screen prompts.

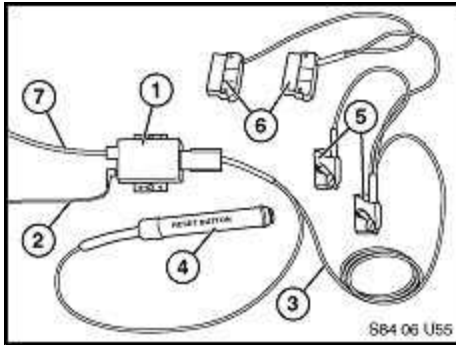
MOXA Kit comprises of:

- MOXA box (1)
- Power cable (2)

- MOXA cable (3) with:
 - Reset button (4)
 - TCU connectors (5)

- The **blue** connector is for E60, E61, E63, E64, E90, E91 vehicles.
 - The **black** connector is for E46, E53, E65, E66, E83 and E85 vehicles.
- Harness connector (6)
 - The **white** connector is for E60, E61, E63, E64, E90, E91 vehicles.
 - The **black** connector is for E46, E53, E65, E66, E83 and E85 vehicles.

- Power cable (2)
- Work shop LAN cable (7)
- MOXA Cable (3)

- Disconnect the vehicle TCU connector.
- Connect MOXA connector (6) to the vehicle harness.
- Connect the MOXA connector (5) to the vehicle TCU (the TCU need not be removed from the vehicle).

NOTE: The remaining unconnected connectors (5) and (6) must not be connected together, or the procedure will fail.

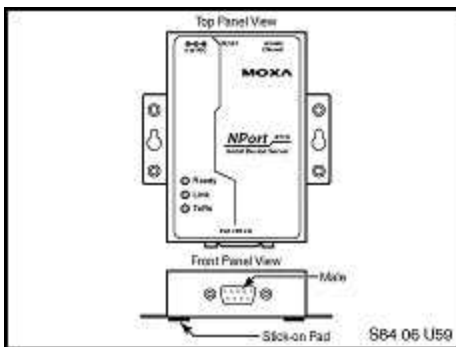
MOXA LED information		
Ready LED	Red	Steady on: Power is on and NPort is booting up Blinking: Indicates an IP conflict or Program is not responding
	Green	Steady on: Power is on and NPort is functioning normally. Blinking: The NPort has been located
	Off	Power is off
Link LED	Orange	10 Mbps Ethernet connection
	Green	100 Mbps Ethernet connection
	Off	Ethernet cable is disconnected
Tx/Rx LED	Orange	Serial port is transmitting data
	Green	Serial port is receiving data
	Off	No data is being transmitted or received through the serial port.

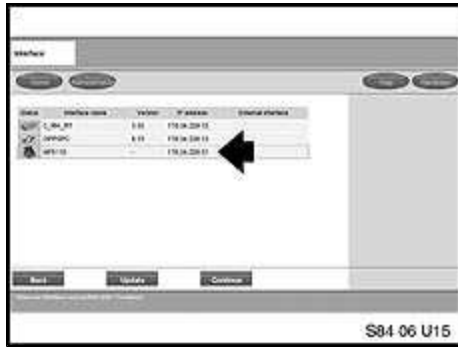
14. Select the correct MOXA box (NP 5110) from the list, and then name the session.

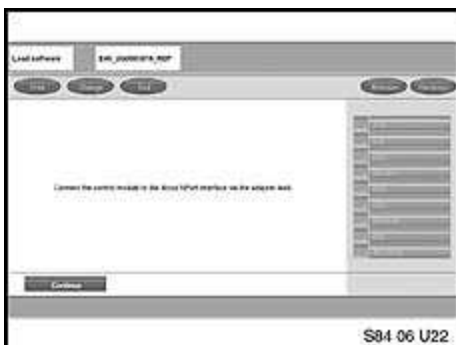
18. Follow the on-screen prompts.
 19. Confirm that all cables going to and from the MOXA box are connected properly.

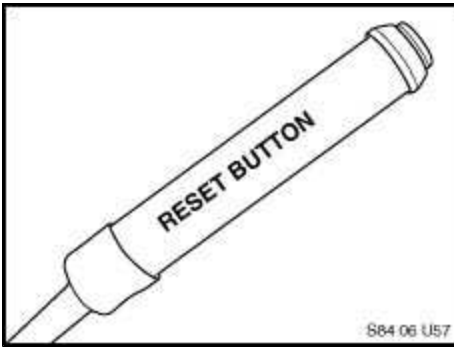
20. Follow the on-screen prompts.
 21. When requested, press the "Reset" button for a **minimum of 5 seconds**, then select "Continue".
 22. Follow the on-screen prompts.
 NOTE:

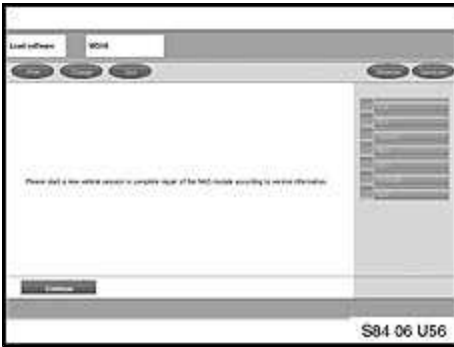
- You will be requested to press the "Reset" button on up to **four** separate occasions.
- The session will time out after 15 minutes if the "Reset" button is not pressed when requested. Performing the programming overnight will fail because the "Reset" button needs to be pressed for the process to complete successfully.

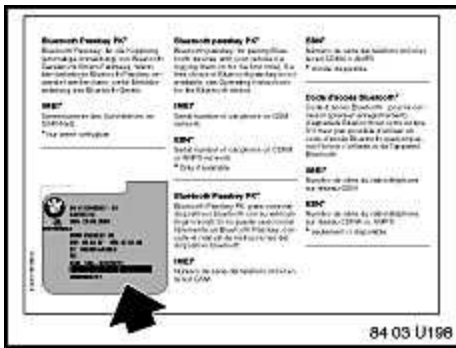
32. Before installing the new TCU, remove one copy of the Electronic Serial Number (ESN) label and place it on the repair order for reference during warranty claim entry. You will be asked for the new TCU "ESN" when submitting a claim via DCSnet. Refer to [SI B01 10 05](#) for more details.

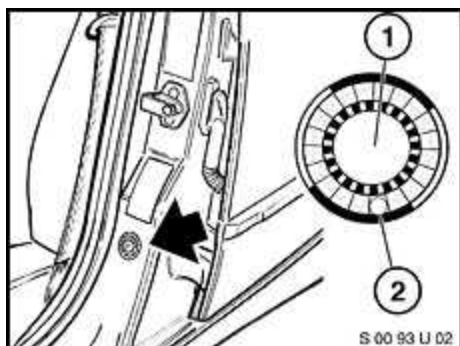
LABEL INSTRUCTIONS

This Service Action has been assigned code number **473**. After the vehicle has been checked, and corrected if necessary, obtain a label (SD 92-295) and:

- Emboss your BMW dealer warranty number in the middle of the label (1);
- Punch out code number **473** printed on the label (2) and,
- Affix the label to the **B** pillar as shown.
