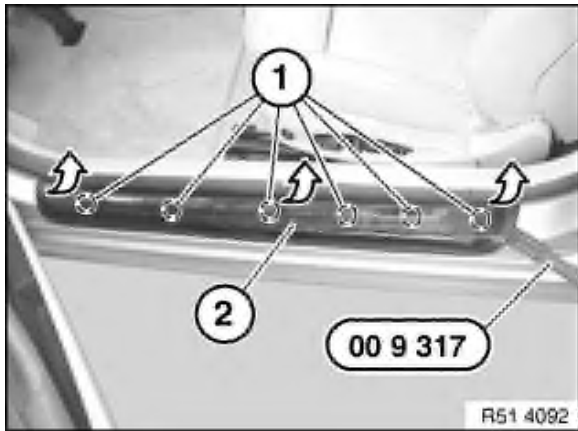
Unclip clips (1) for finishing strip (2) with special tool 00 9 317 .  
Remove finishing strip (2).

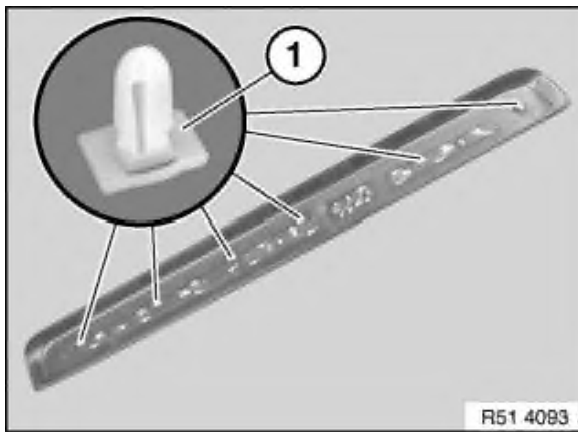
If necessary, replace faulty clips (1).

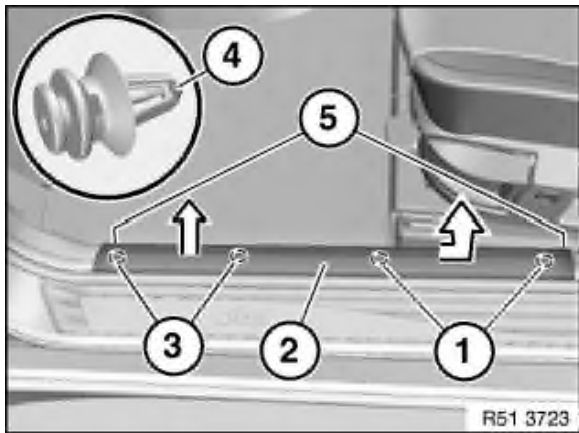
Disengage retaining lugs (5) of front entrance cover strip (2) from both adjoining panels.

Carefully lever out front entrance cover strip (2).

Lever out front entrance cover strip (2) at front retaining points (3).

Pull back front entrance cover strip (2) and feed out of rear retaining points (1).

Position front entrance cover strip (2) preinstalled with clips (4) on associated bores and clip into place.

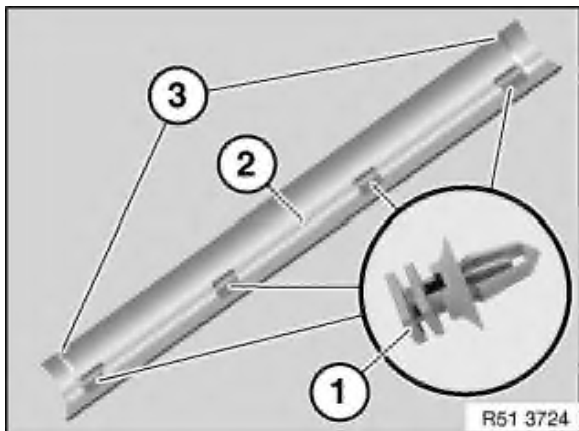
Rails of front entrance cover strip (2) must not be damaged.

Retaining lugs (3) of front entrance cover strip (2) must not be damaged.

If necessary, lever out remaining clips (1) in floor panel.

If necessary, replace faulty clips (1).

Slide clips (1) into rails of front entrance cover strip (2).

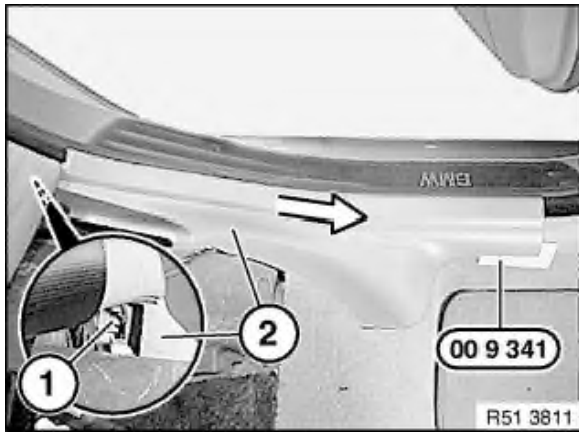
Release screw (1) on entrance cover strip (2).

Attach special tool 00 9 341 at front under entrance cover strip (2).

Pull out entrance cover strip (2) forwards/downwards.

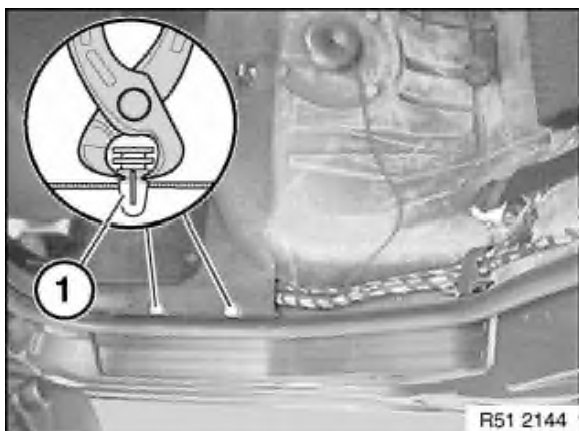
Lever out clips (1) with pliers (head of pliers surface-ground).

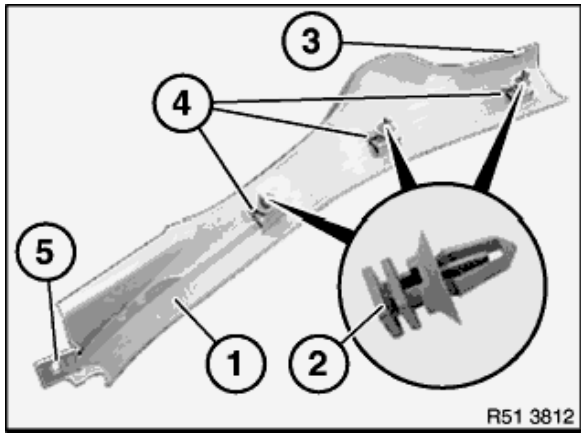
Push clips (2) onto entrance cover strip (1).

Following parts of entrance cover strip (1) must not be damaged or missing:

- 2 Clips
- 3 Retaining lug
- 4 Guides for clips
- 5 Bore

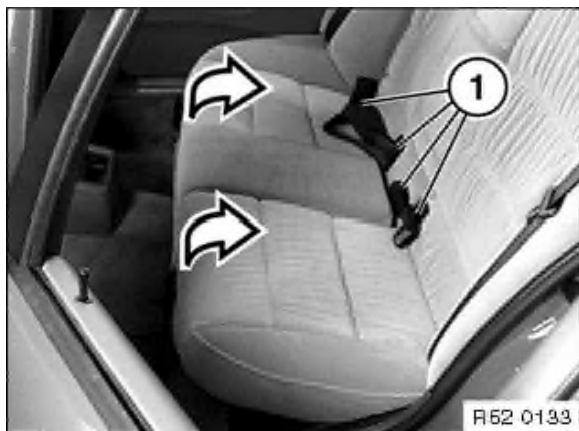
Unclip rear seat on left/right towards top.

Lift out seat.

Feed belt buckles (1) through designated openings into correct location.

Guide lap belt behind seat edge upwards.

Make sure ISOFIX covers are correctly engaged.

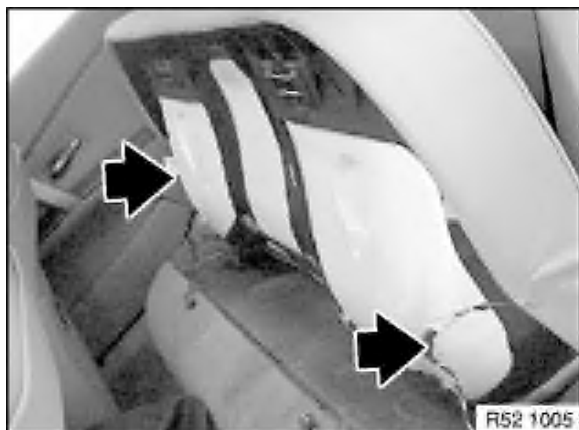
Unfasten plug connection.

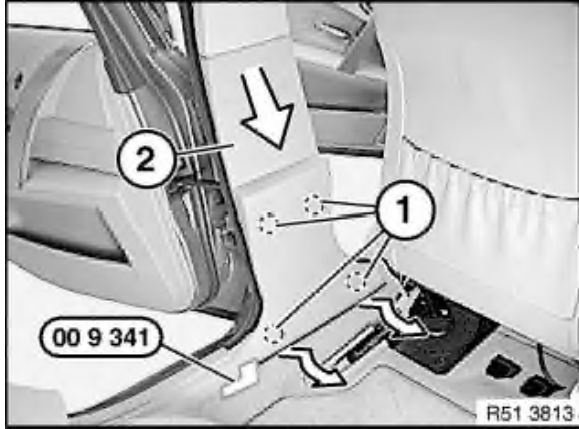
Partially detach mocket in area of B-pillar trim.

Insert special tool 00 9 341 under rear entrance cover strip (inside).

Unclip trim for door pillar (2) by pulling inwards (1), then pull downwards to remove.

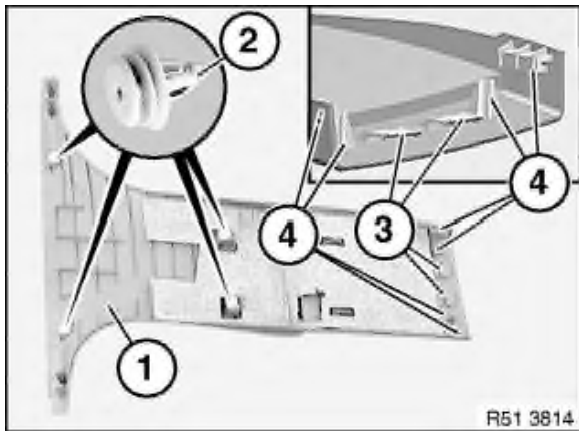
Following parts of trim for door pillar (1) must not be damaged or missing:

- 2 Clips
- 3 Hooks
- 4 Guides

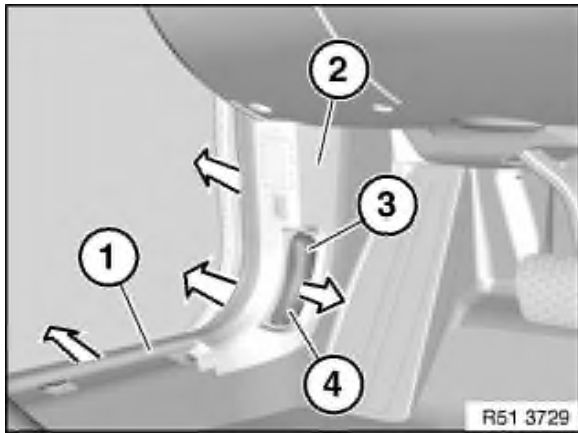
Release door mocket (1) in area of footwell side trim panel on A-pillar on left (2).

Unscrew bolt (3).

Remove engine hood actuator lever (4) from footwell side trim panel on A-pillar on left (2).

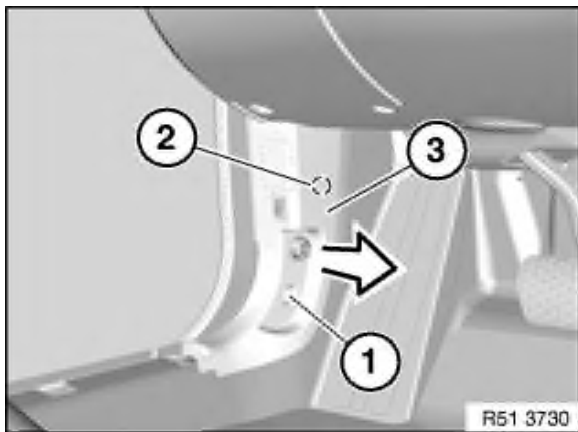
Unscrew bolt (1).

Unclip footwell side trim panel on A-pillar on left (3) in direction of arrow from retaining point (2) and remove.

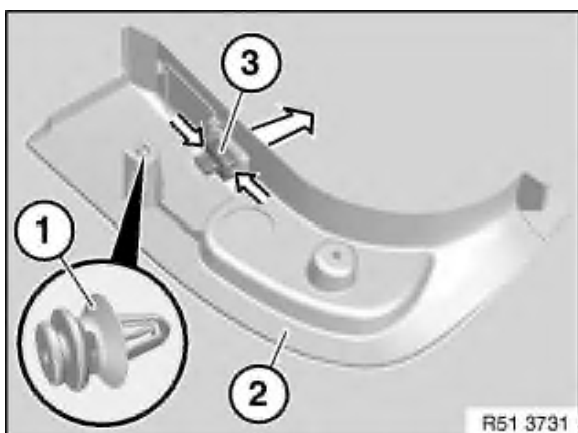
If necessary, lever out clip (1) remaining in bore.

If necessary, replace faulty clip (1).

Place footwell side trim panel on A-pillar on left (2) preinstalled with clip (1) on associated bore and clip into place.

Press catches and remove switch for unlocking rear lid (3).

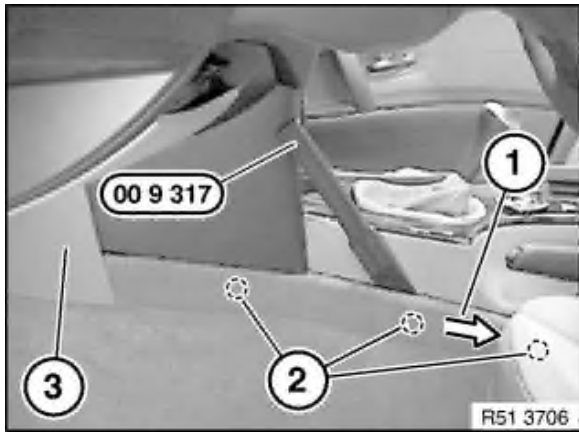
Drive bottom trim (1) towards rear with special tool 00 9 317 and remove.

Make sure bottom trim (1) is correctly seated at retaining points (2).

Feed bottom trim (1) correctly into trim for pedal assembly (3).

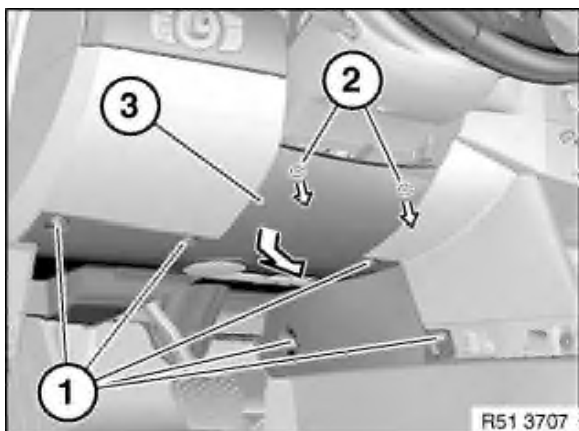
Release screws (1).

Unclip trim for pedal assembly (3) at retaining points (2) in direction of arrow.

Pull back trim for pedal assembly (3).

Disconnect associated plug connections and remove trim for pedal assembly (3).

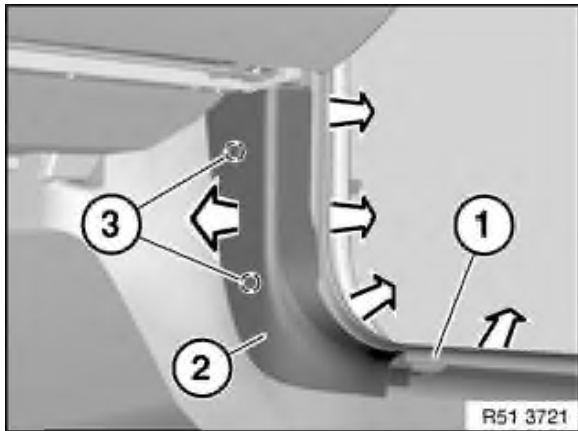
Release door mocket (1) in area of footwell side trim panel on A-pillar on right (2).

Unclip footwell side trim panel on A-pillar on right (2) in direction of arrow from retaining points (3).

Remove footwell side trim panel on A-pillar on right (2).

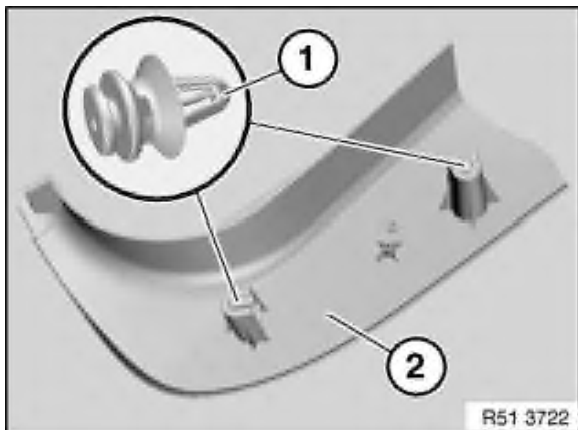
If necessary, lever out clips (1) remaining in bores.

If necessary, replace faulty clips (1).

Place footwell side trim panel on A-pillar on right (2) preinstalled with clips (1) on associated bores and clip into place.

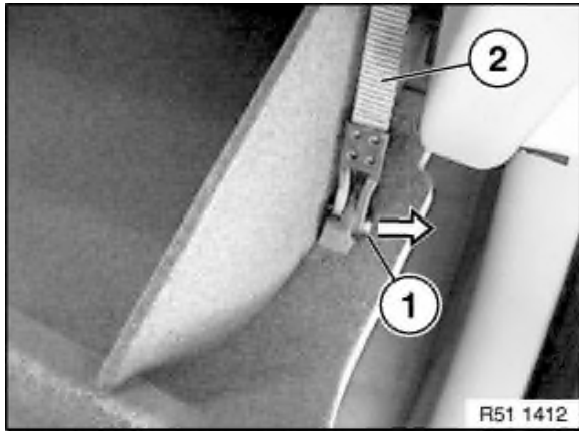
Open glovebox.

Unclip pin (1) from retaining strap (2).

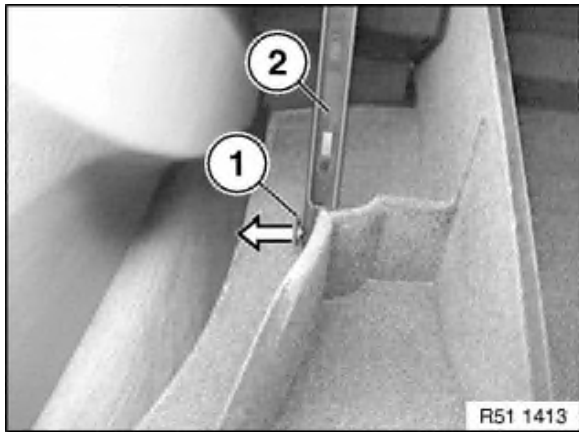
Unclip pin (1) from shock absorber (2).

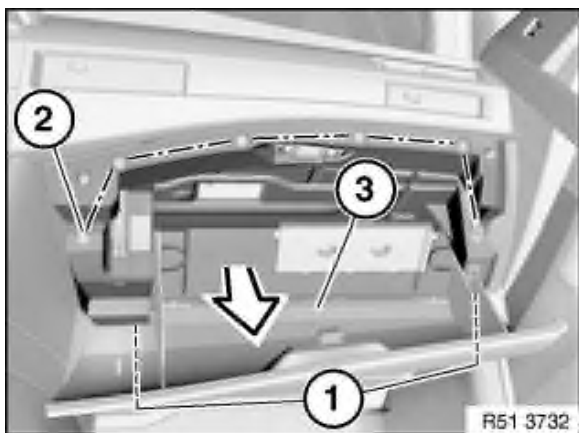
Release screws (1).

Release screws (2) and pull back right glovebox with housing (3).

Disconnect associated plug connections and remove right glovebox with housing (3).

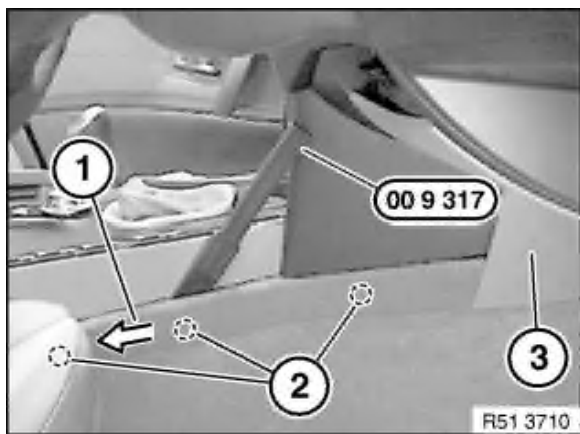
Drive bottom trim (1) towards rear with special tool 00 9 317 and remove.

Make sure bottom trim (1) is correctly seated at retaining points (2).

Feed bottom trim (1) correctly into bottom right trim for instrument panel (3).

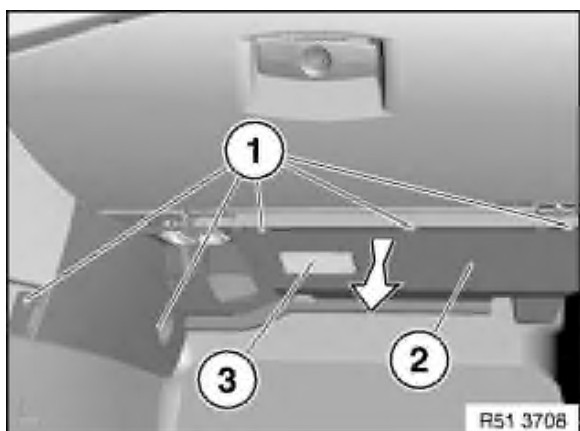
Release screws (1).

Move bottom right trim for instrument panel (2) slightly forwards and feed out towards rear.

Disconnect plug connection of footwell light (3).

Remove bottom right trim for instrument panel (2).

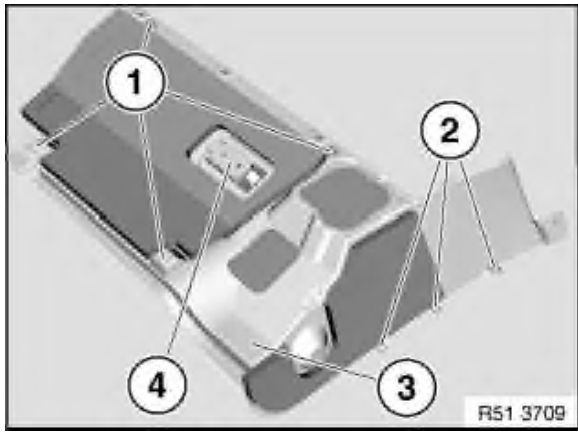
Mounts (1) and guides (2) of bottom right trim for instrument panel (3) must not be damaged.

Make sure mounts (1) are correctly seated.

- Remove footwell light (4).

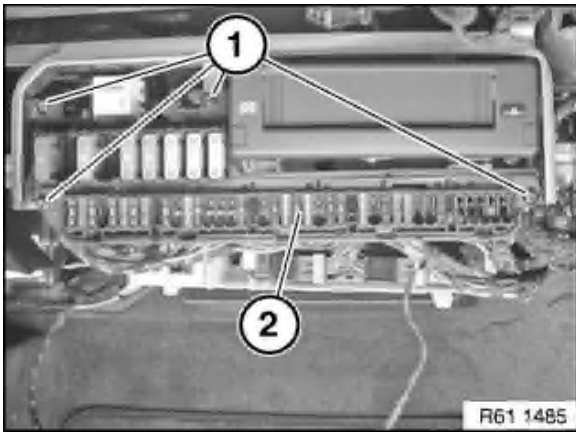
Release screws (1) and remove distribution box (2).

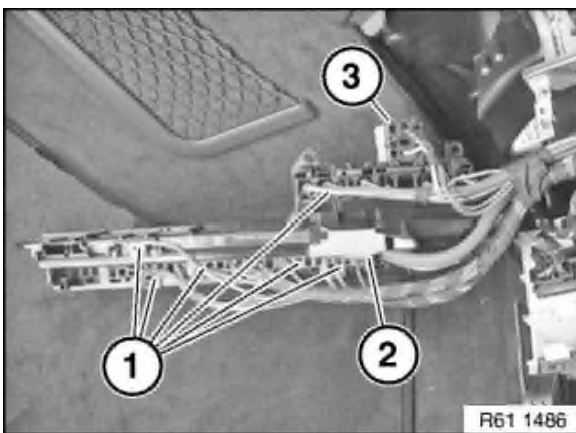
Disconnect all plug connections (1).

Unlock relay base (3) and disconnect.

Open cover (2) on positive battery cable and release nut underneath.

Tightening torque 61 21 2AZ .

Disconnect positive battery cable from distribution box.

Make sure positive battery cable is correctly seated on fuse box.
